APPENDIX 1

Rainwater Harvesting Practises, Photograph Inventory

APPENDIX 1. RAINWATER HARVESTING PRACTISES, PHOTOGRAPH INVENTORY

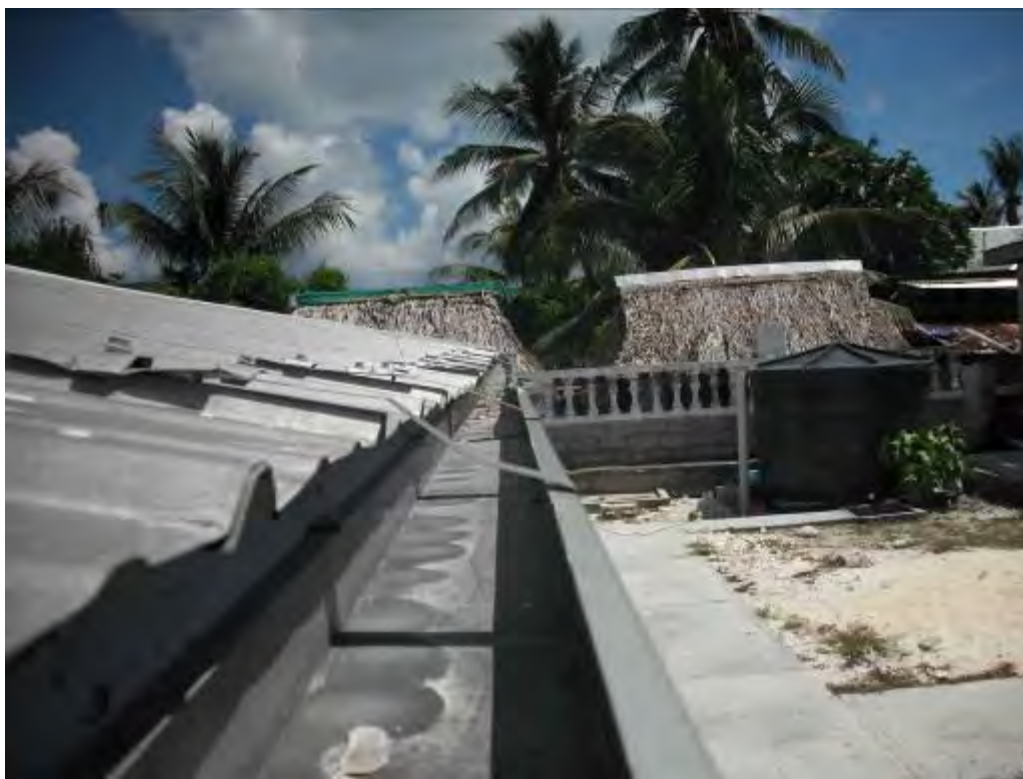
A1.1.1 Well supported galvanized steel maneaba guttering, fairly clear of debris, Infrequent downpipes to underground transmission.

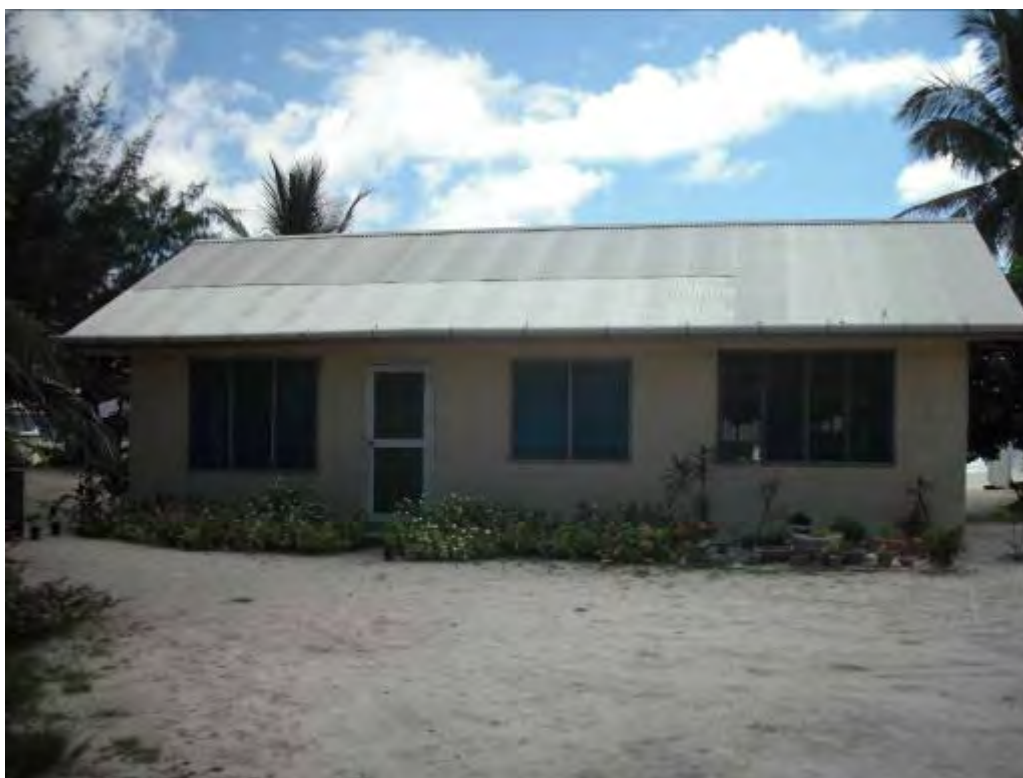
A1.1.2 Split PVC pipe guttering. Well supported and with a fall towards the downpipe. Good clean roof catchment for collection with no overhanging vegetation.

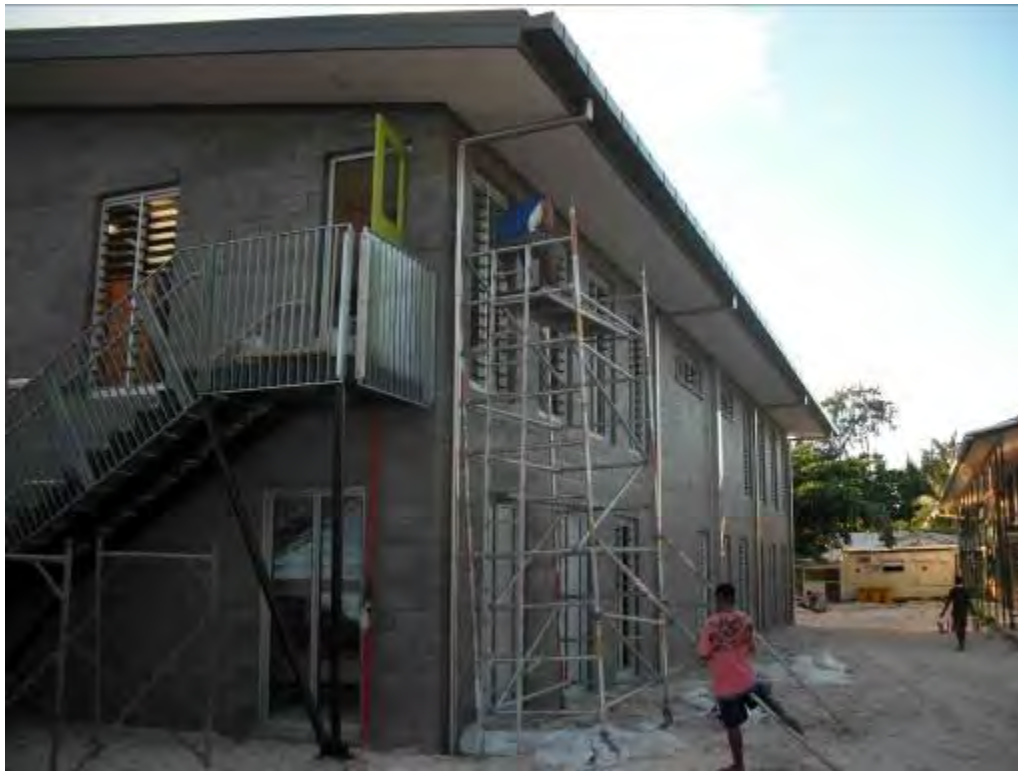
A1.1.3 New zinalume[®] guttering and stainless steel downpipe to underground PVC transmission pipes to multiple 25KL polytanks being constructed. Downpipes are well supported.

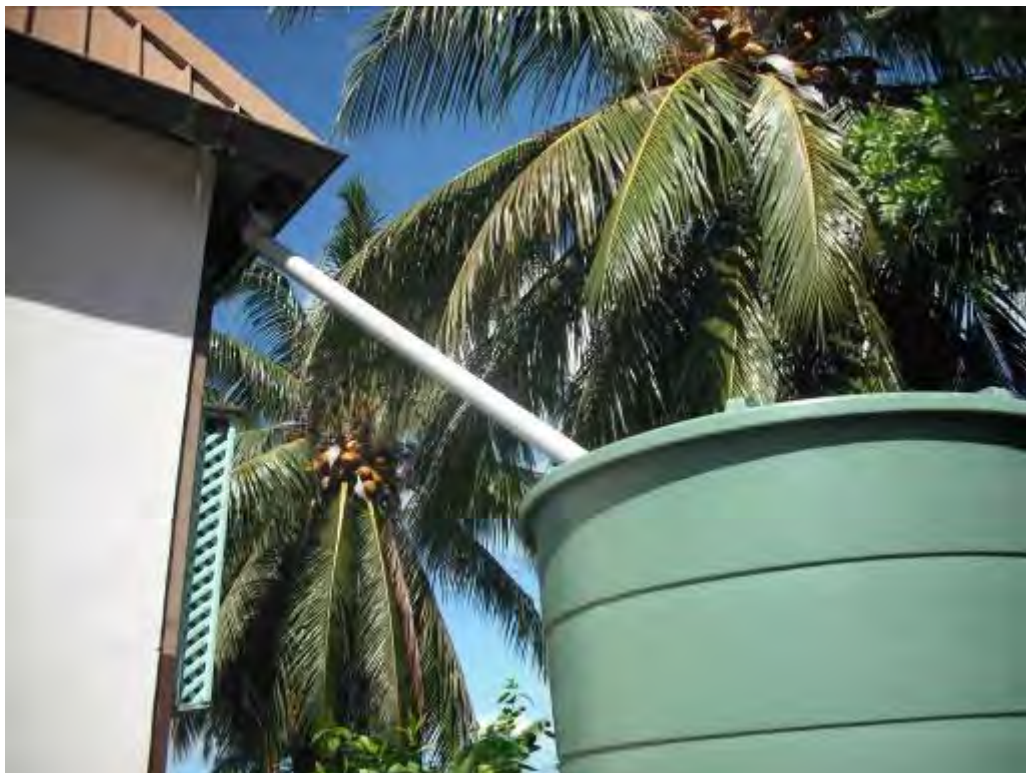
A1.1.4 V-shaped galvanised steel guttering. Government owned hotel. Inadequate for large roof area, makeshift unsupported downpipe to polytank.

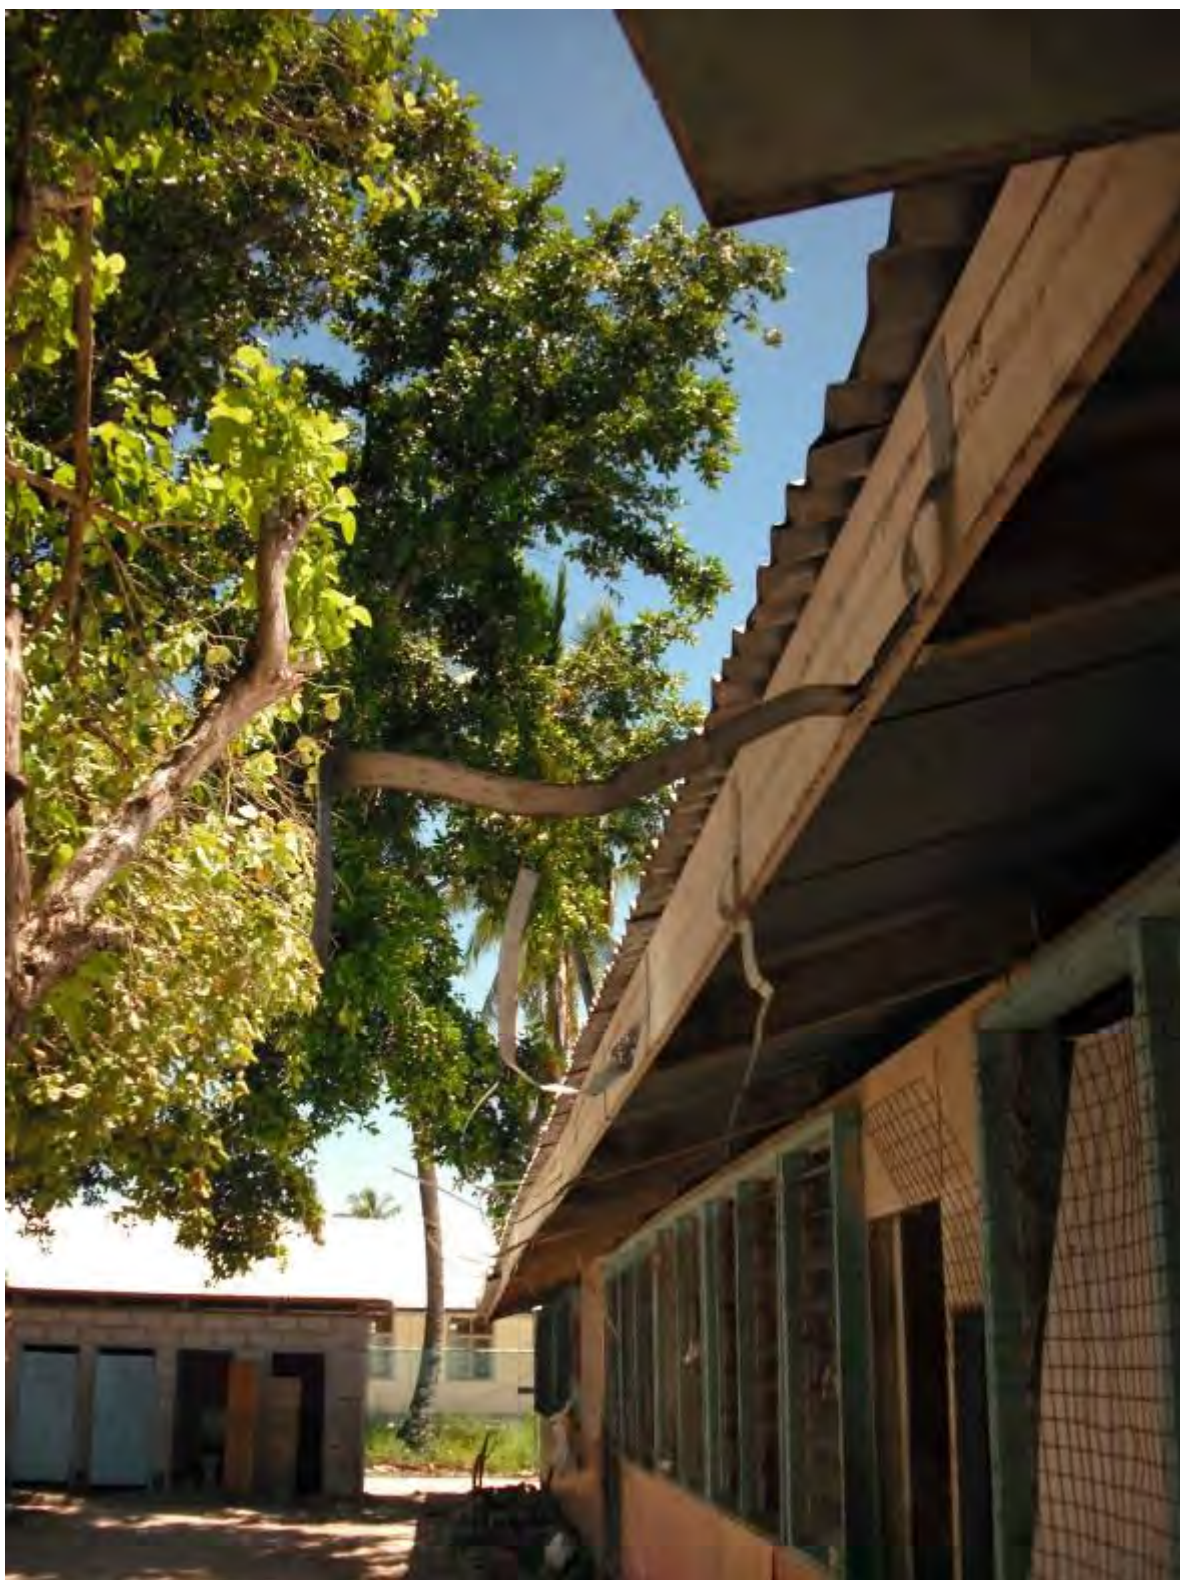
A1.1.5 Guttering missing, poor maintenance. Overhanging trees.

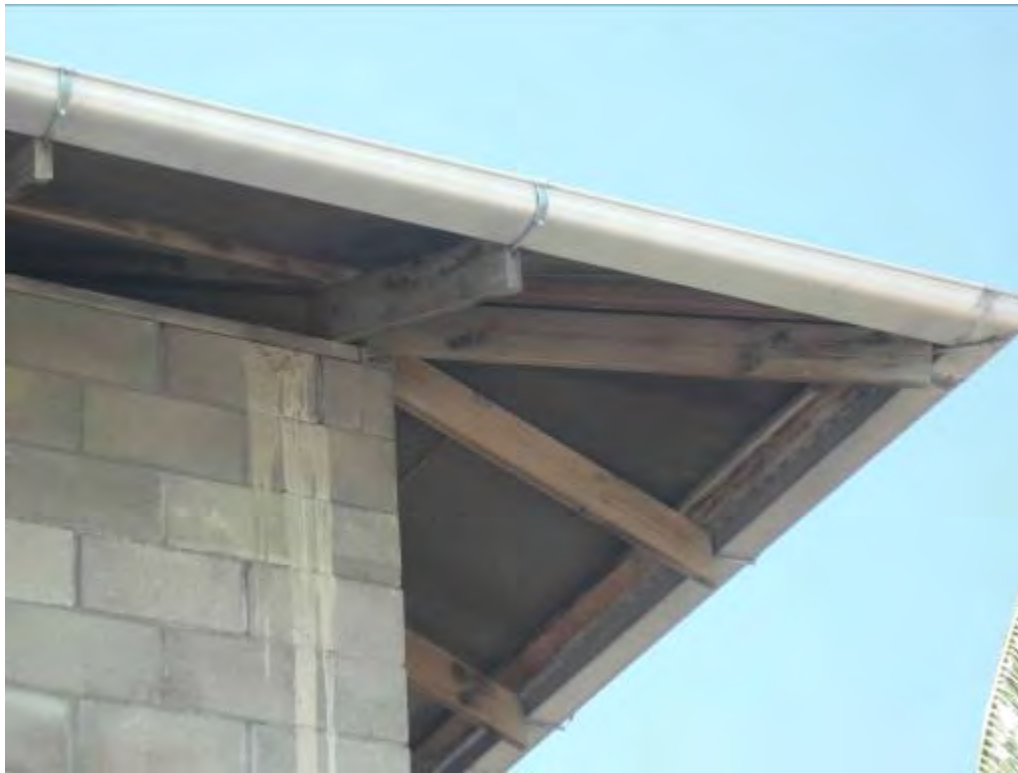
A1.1.6 Small cross-section PVC guttering at a primary school, not suitable for this large roof catchment with inadequate downpipes

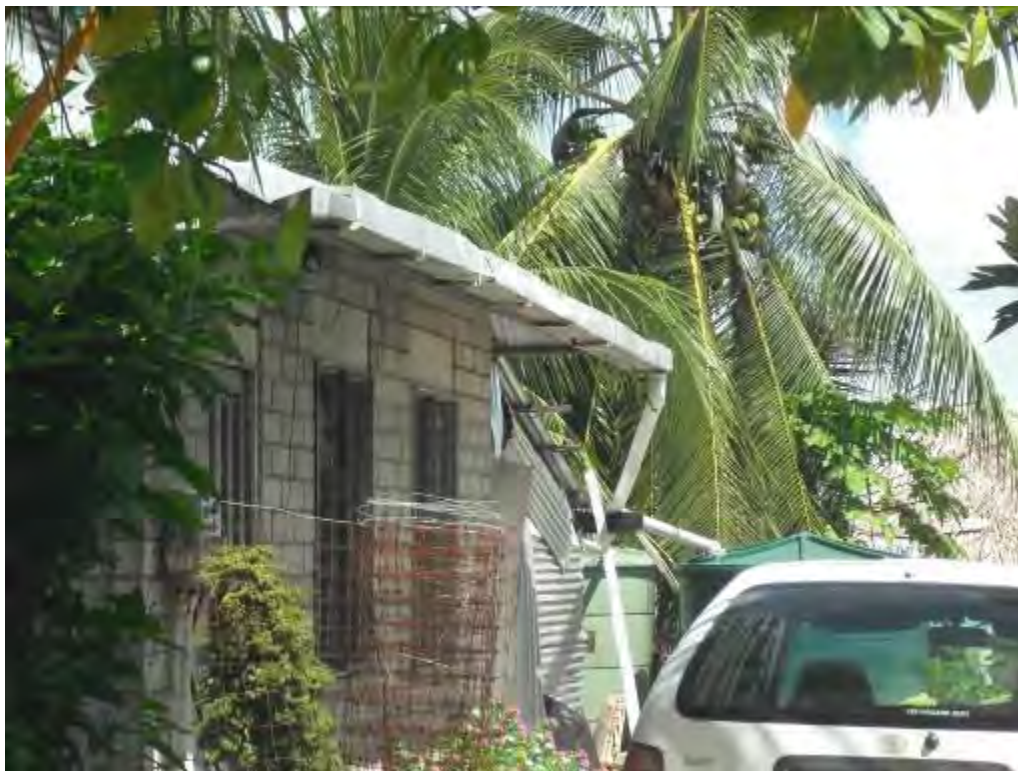
A1.1.7 Large cross-section makeshift guttering. Made from folded galvanised iron sheet. Unsupported downpipe, liable to fail.

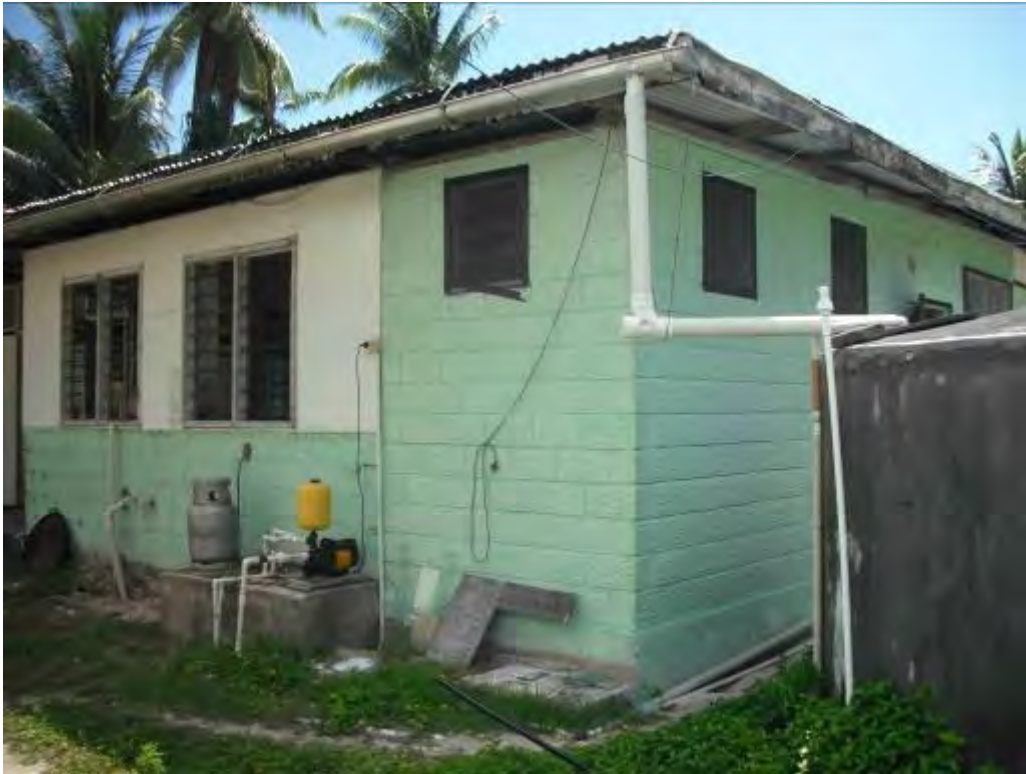
A1.1.8 Small cross-section PVC gutter suitable for small roof area, single unsupported downpipe (liable to failing) to ferro-cement tank.

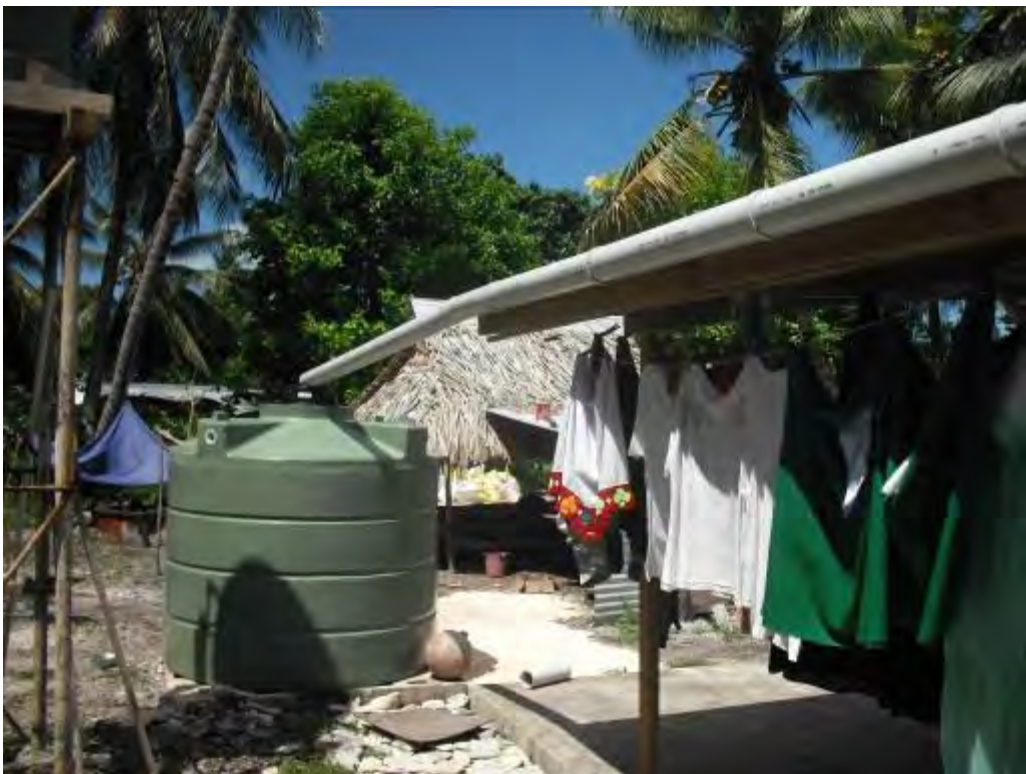
A1.1.9 Split PVC guttering, well supported. Unsupported downpipe to new polytank.

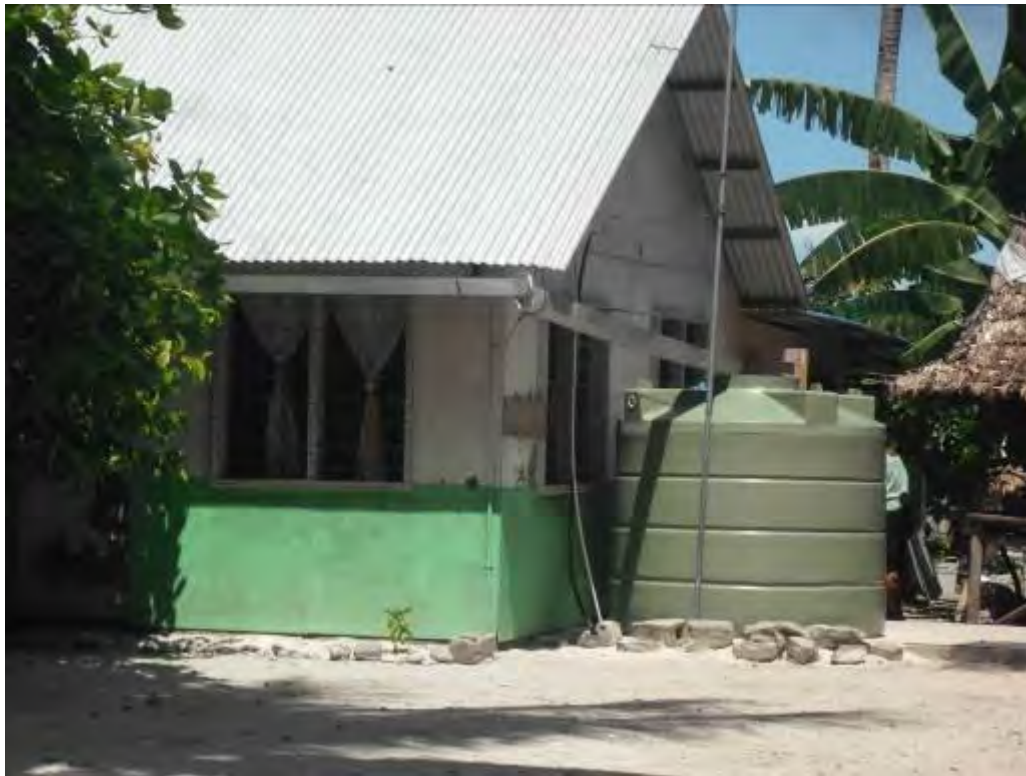
A1.1.10 Poor makeshift guttering and makeshift transmission to brand new polytank.

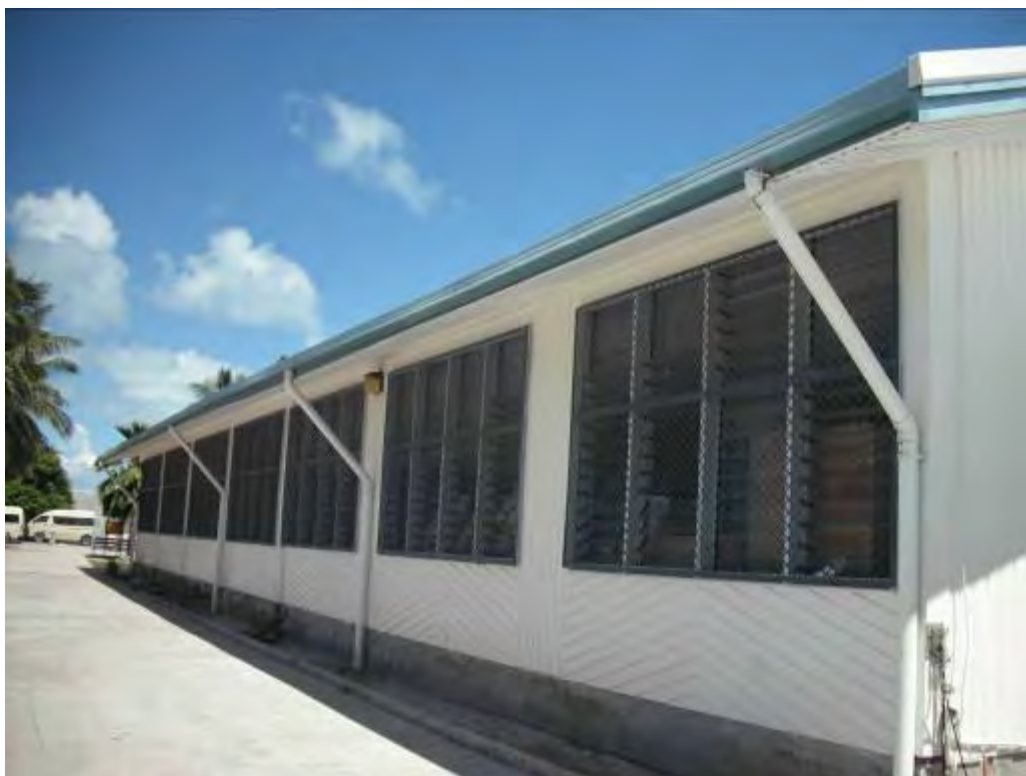
A1.1.11 Good sized gutter (with high outer wall to reduce splash losses) with adequate downpipes to underground transmission. This system is old (*c.* 15 years) but well maintained.

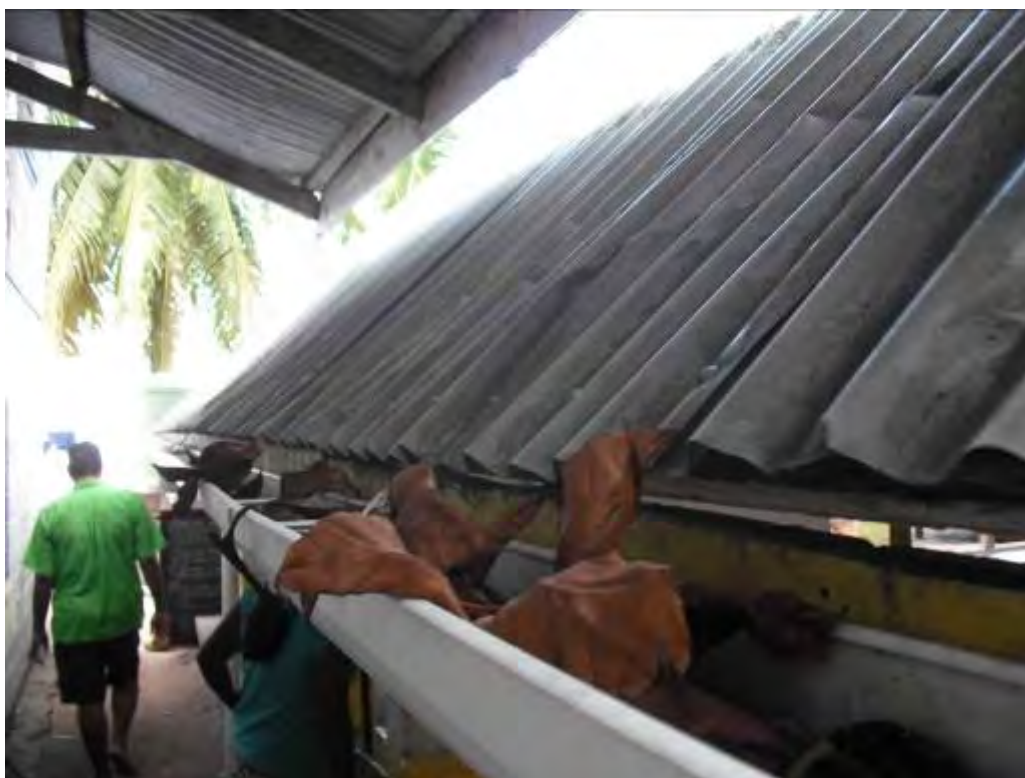
A1.1.12 Leaves in gutter.

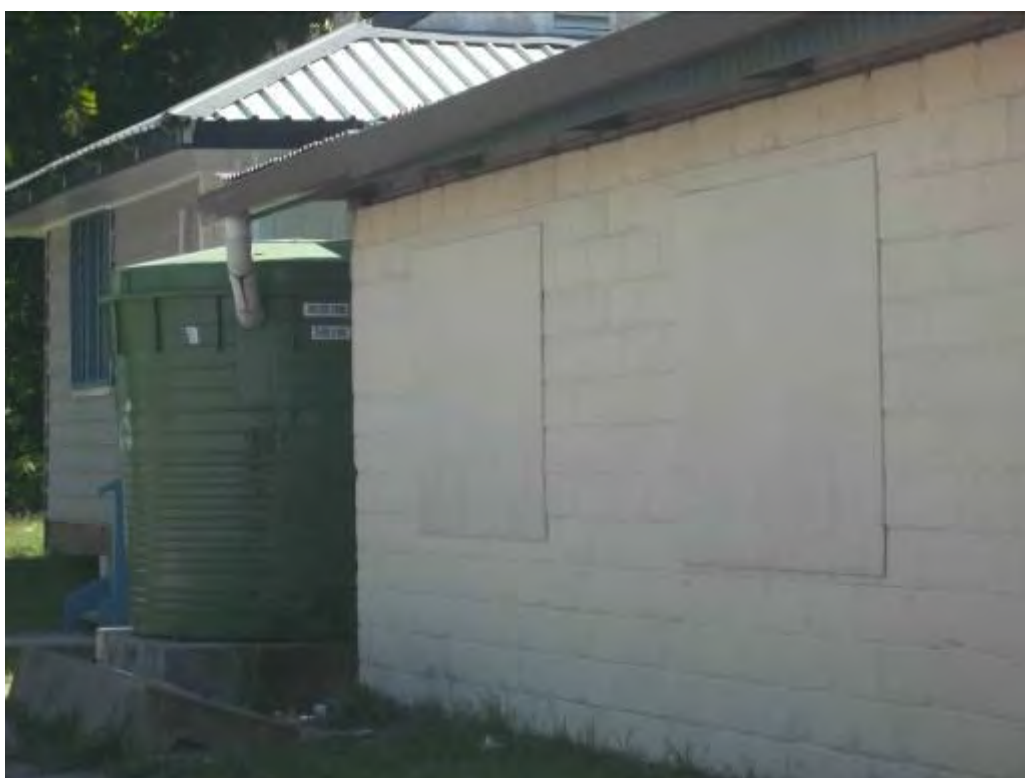
A1.1.13 Good fall on gutter.

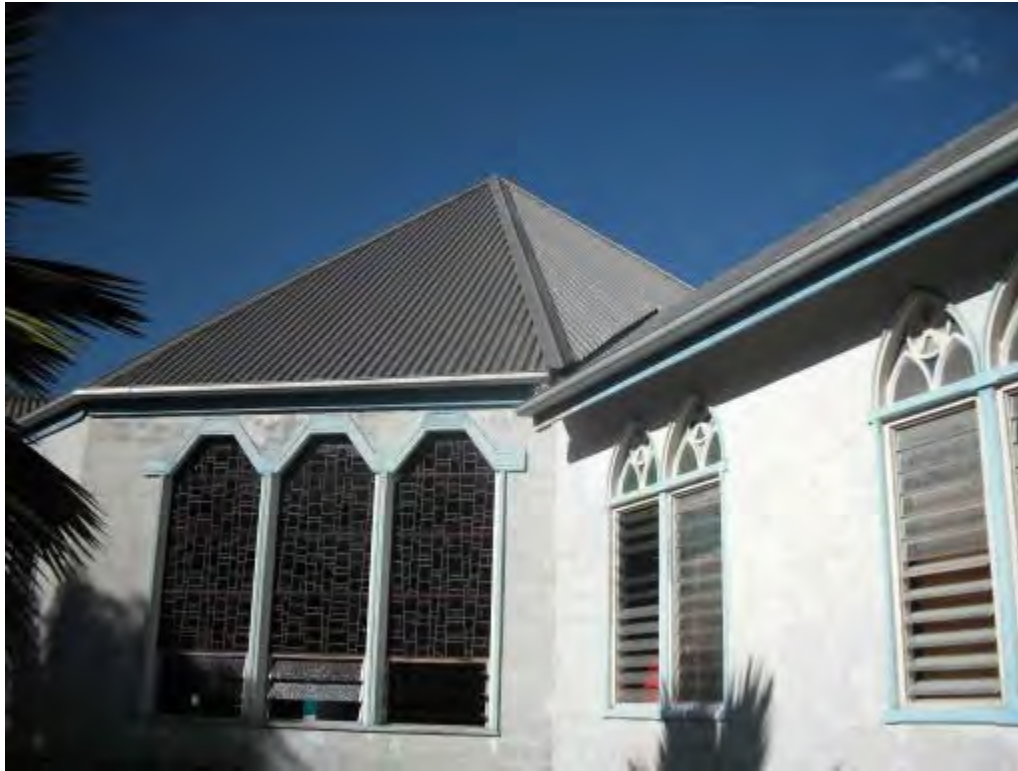
A1.1.14 Large roof catchment area with inadequate gutter or downpipe size. Limited fall on gutter.

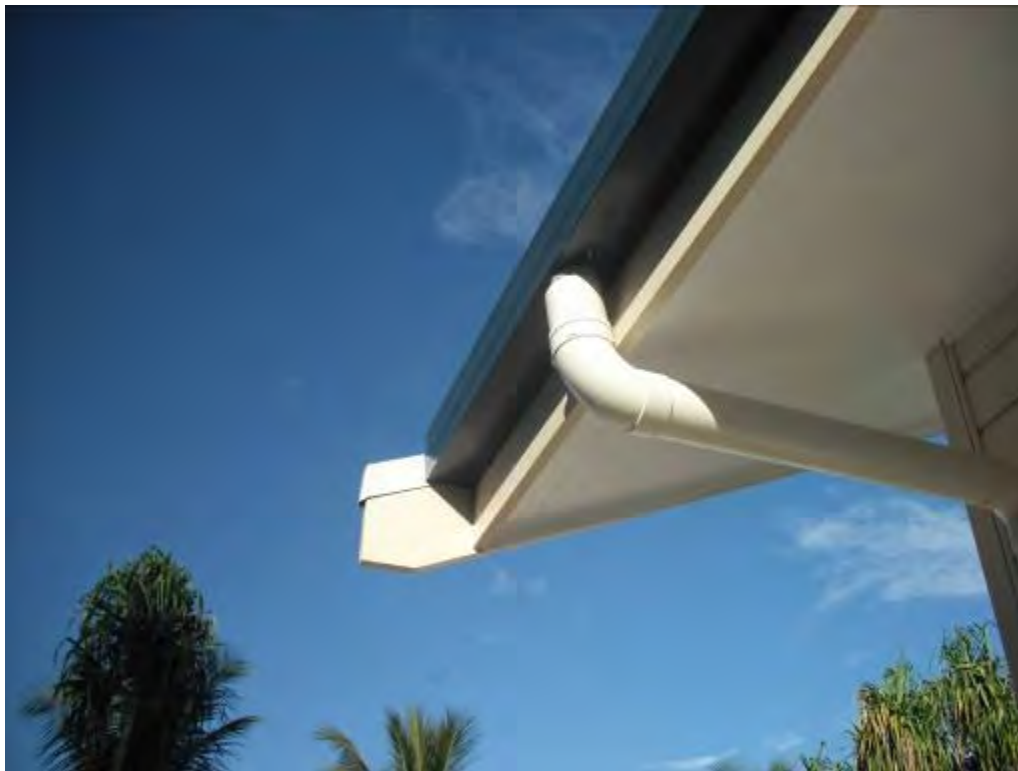
A1.1.15 Good gutter to downpipe connection using a gutter outlet.

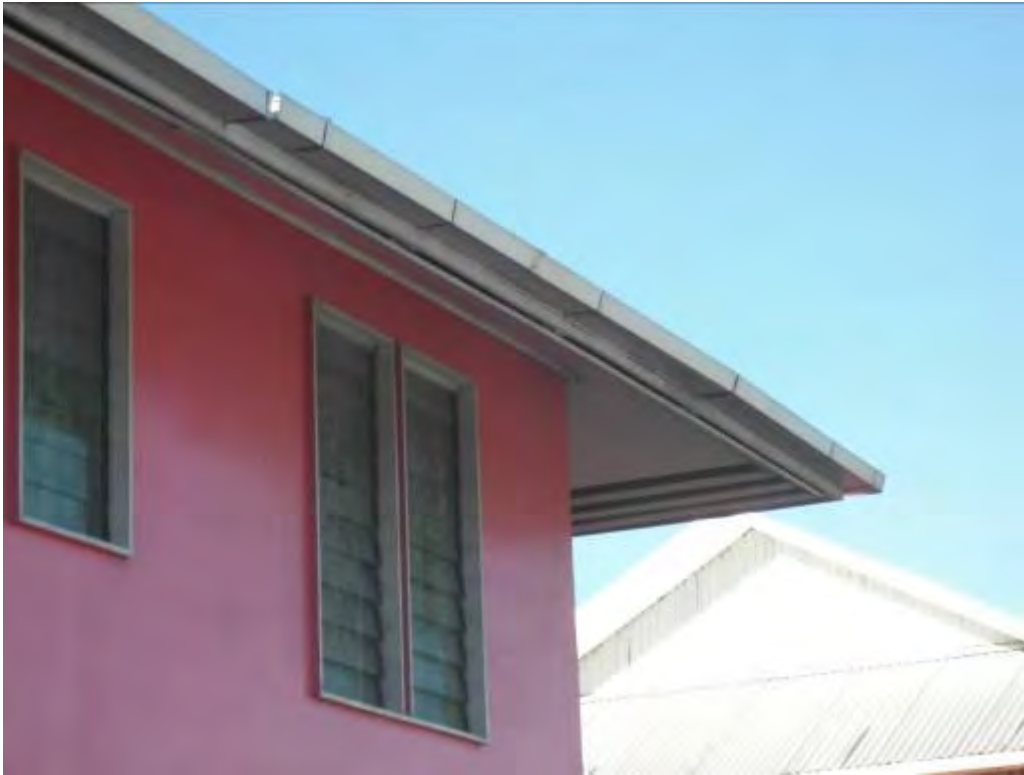
A1.1.16 Newly fitted gutter already broken, and inadequate fall. Poor materials and installation technique.

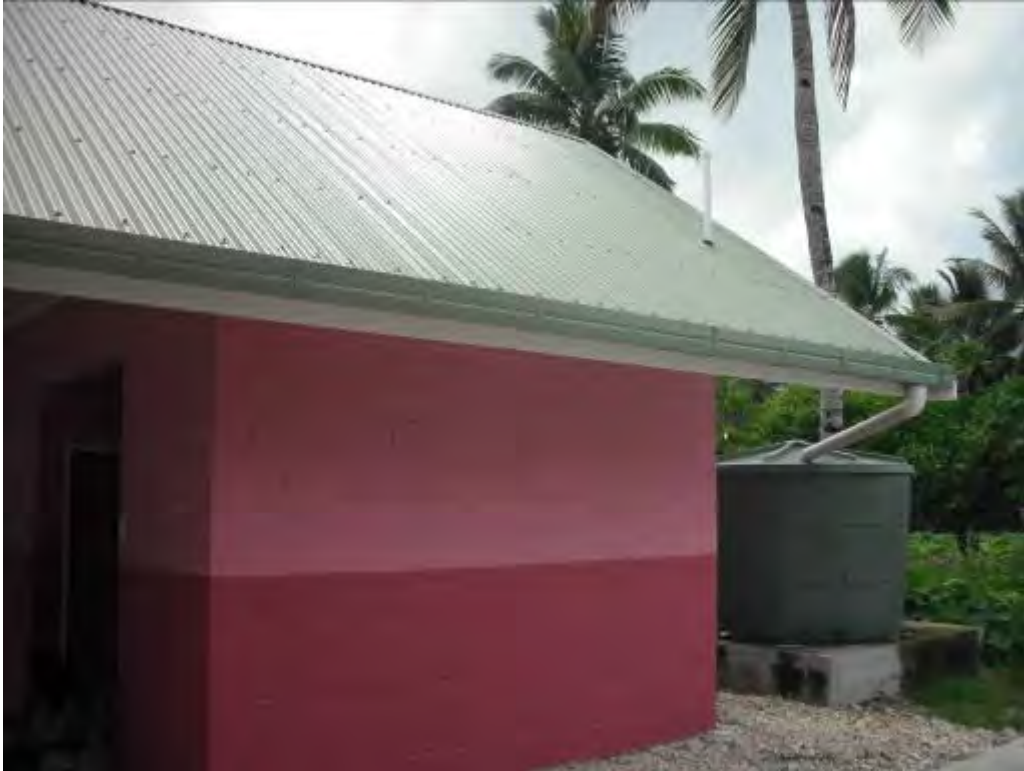
A1.1.17 Newly installed gutter, downpipe and tank. Well fitted but downpipe not secured so liable to failure

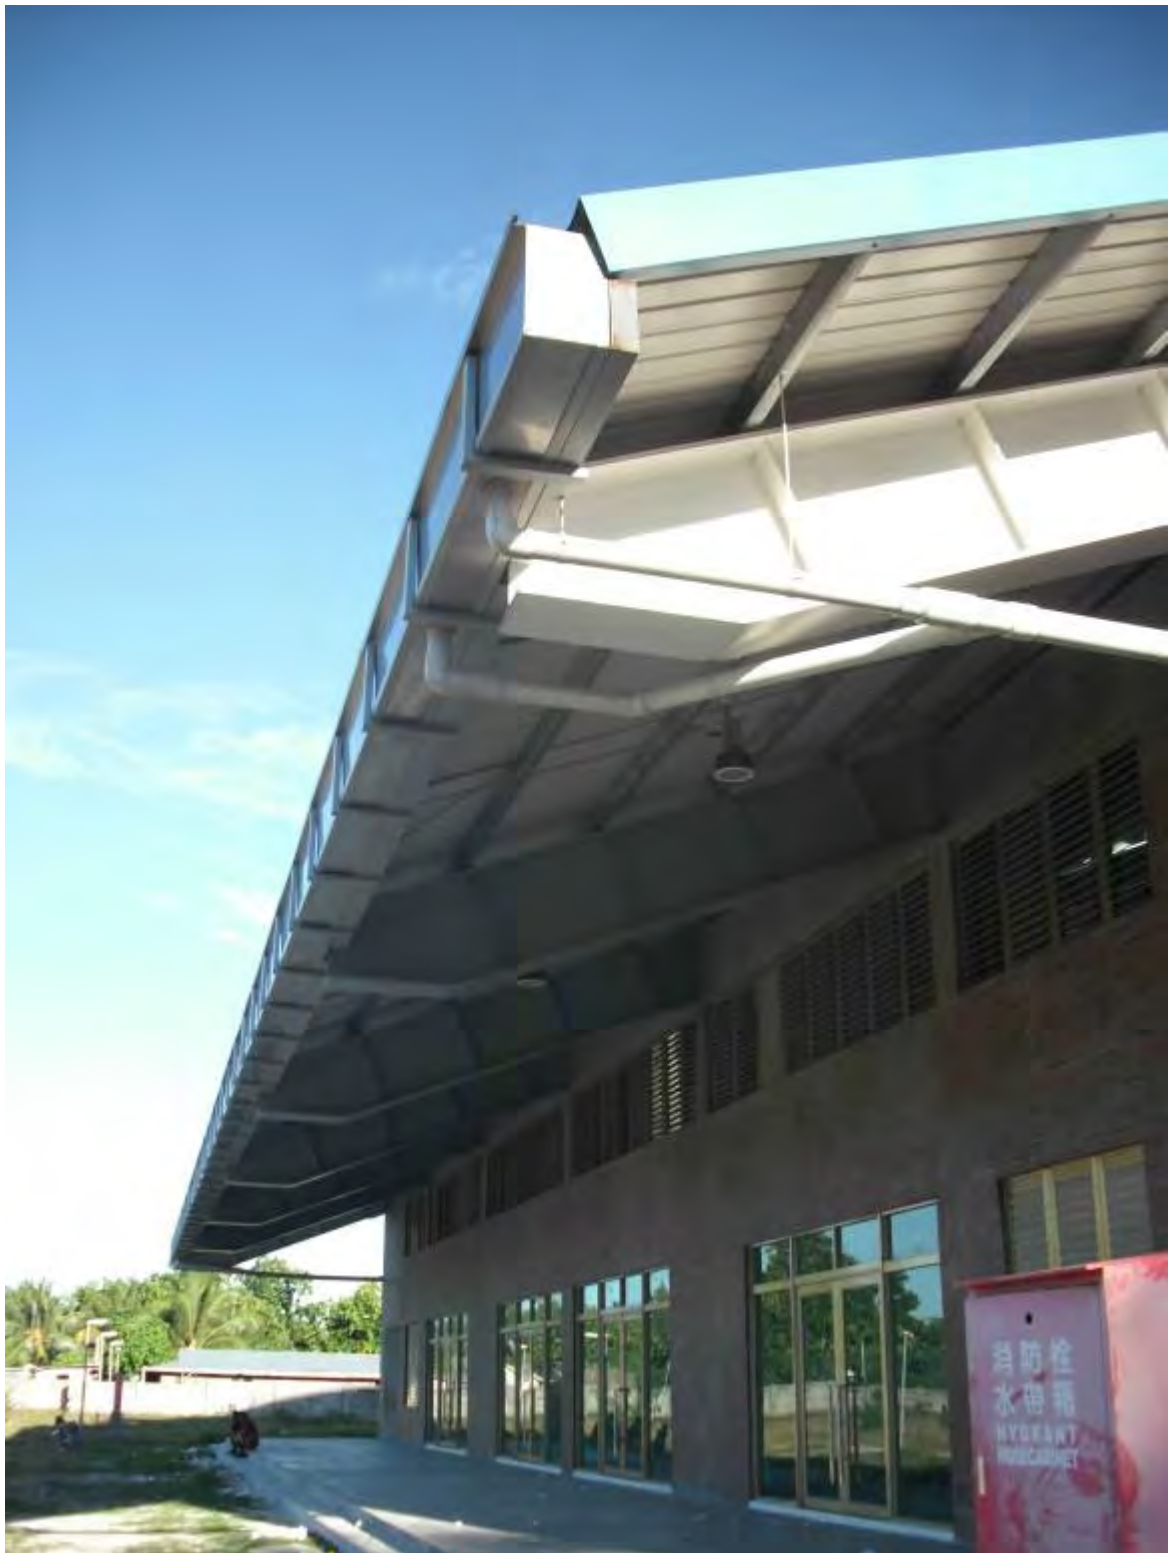
A1.1.18 Newly fitted very large cross-section gutters and large diameter downpipes to accept water from a large roof catchment. Water routed underground to large reinforced concrete cistern.

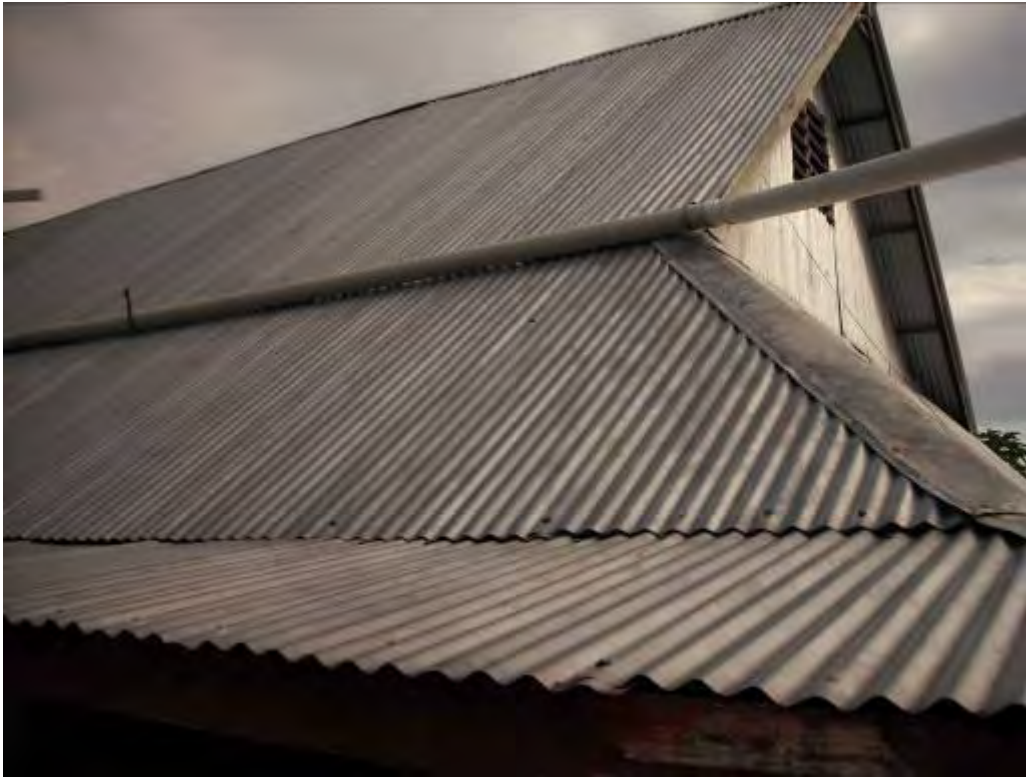
A1.1.19 Split PVC gutter half way up maneaba roof. Unsupported downpipe liable to fail.

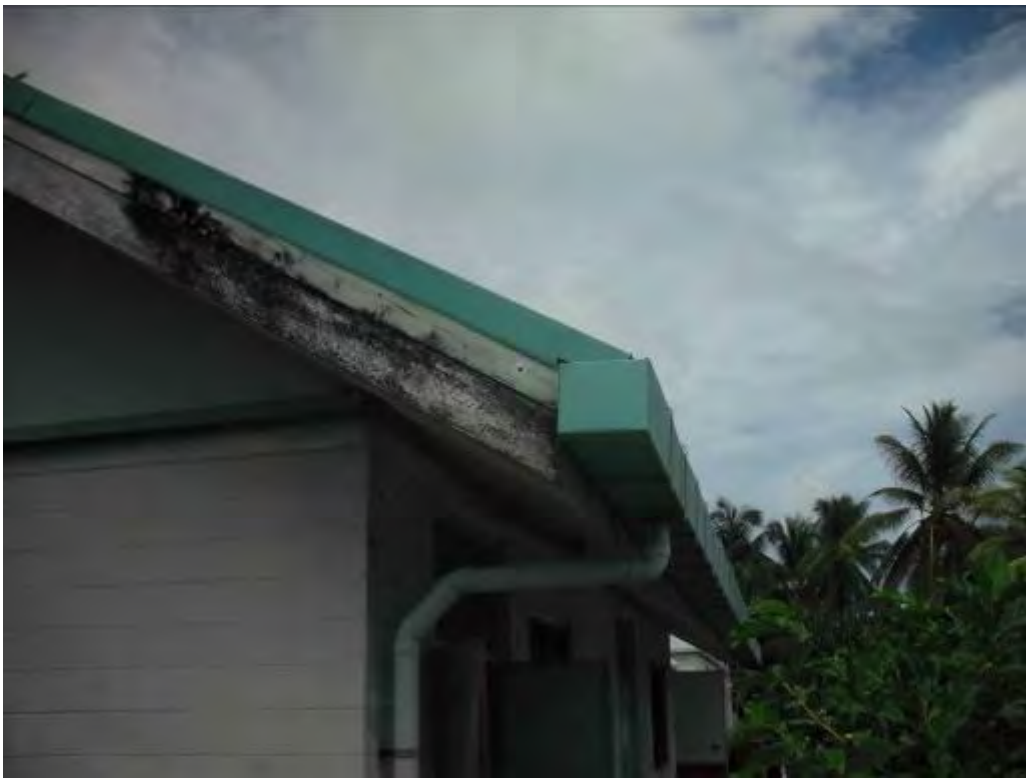
A1.1.20 Large cross-section gutters and well supported downpipe to underground transmission. System in place for *c.* 20 years but well maintained.

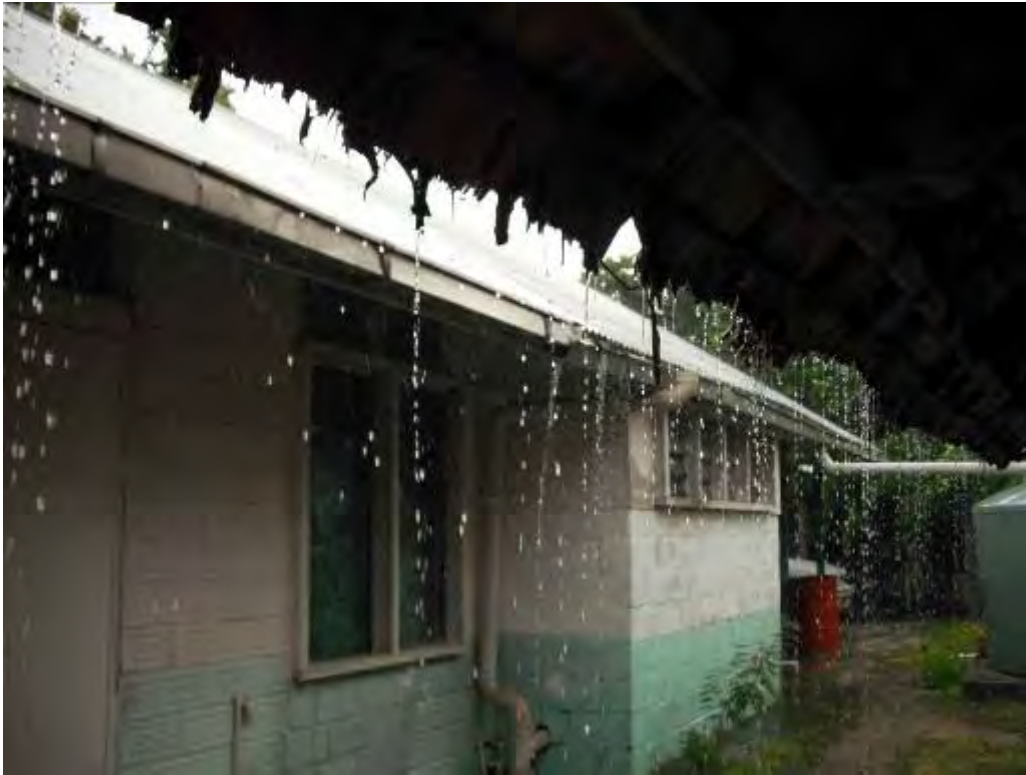
A1.1.21 Incomplete, poorly maintained gutter system unconnected to downpipe. Unsupported downpipe. Thatch roof in foreground unsuitable for rainwater collection.

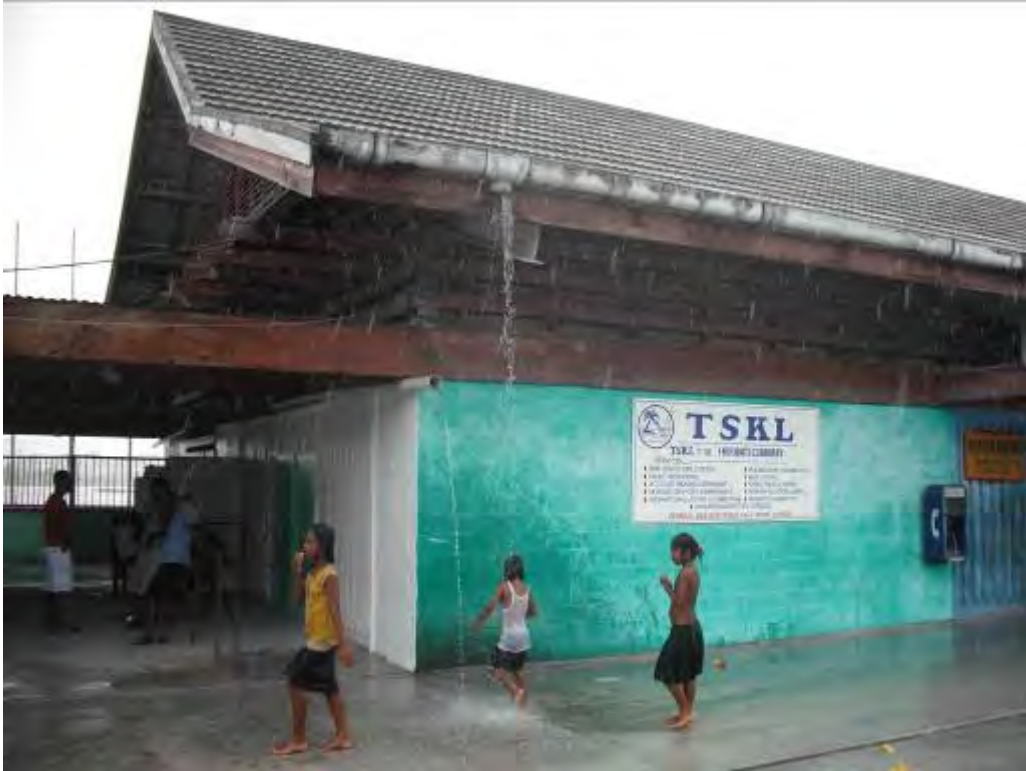
A1.1.22 Large cross-section gutters, missing downpipe.

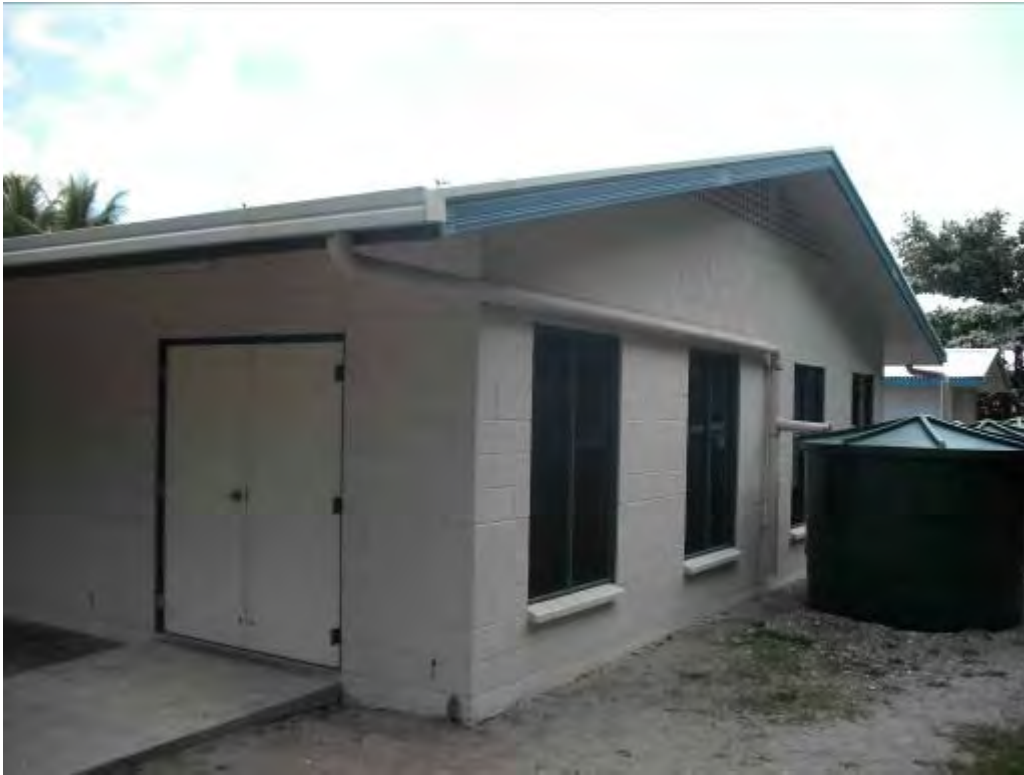
A1.2.1 Simple downpipe first flush device to divert a small quantity of water. Manually operated.

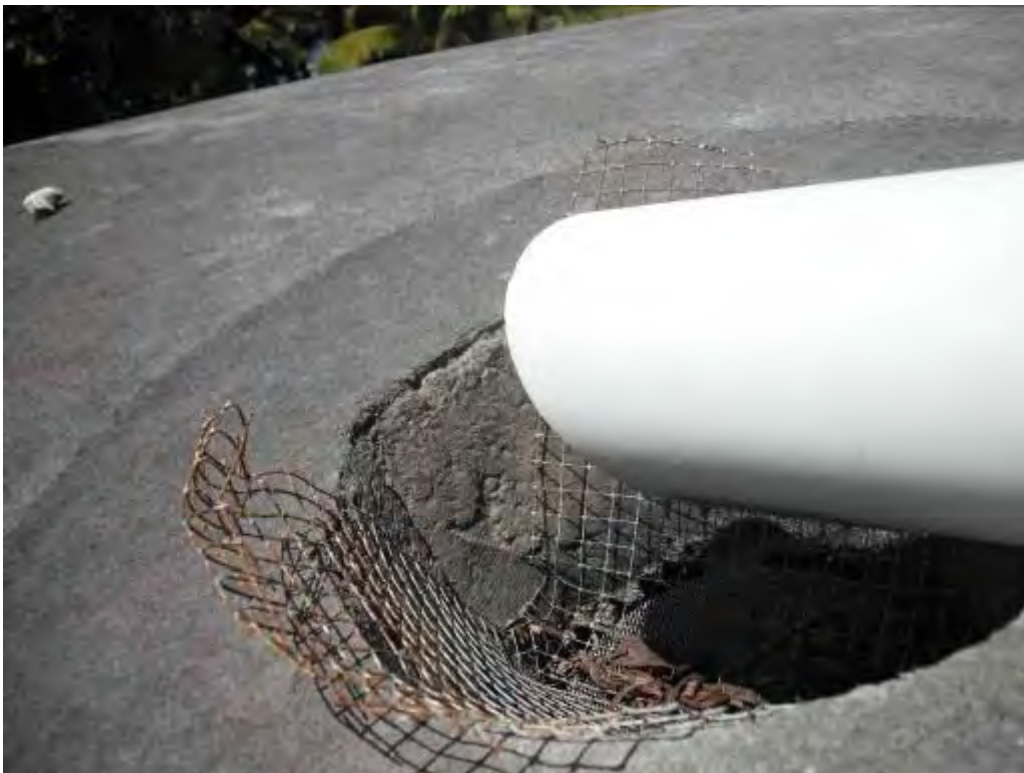
A1.2.2 Makeshift entry screen on ferro-cement tank.

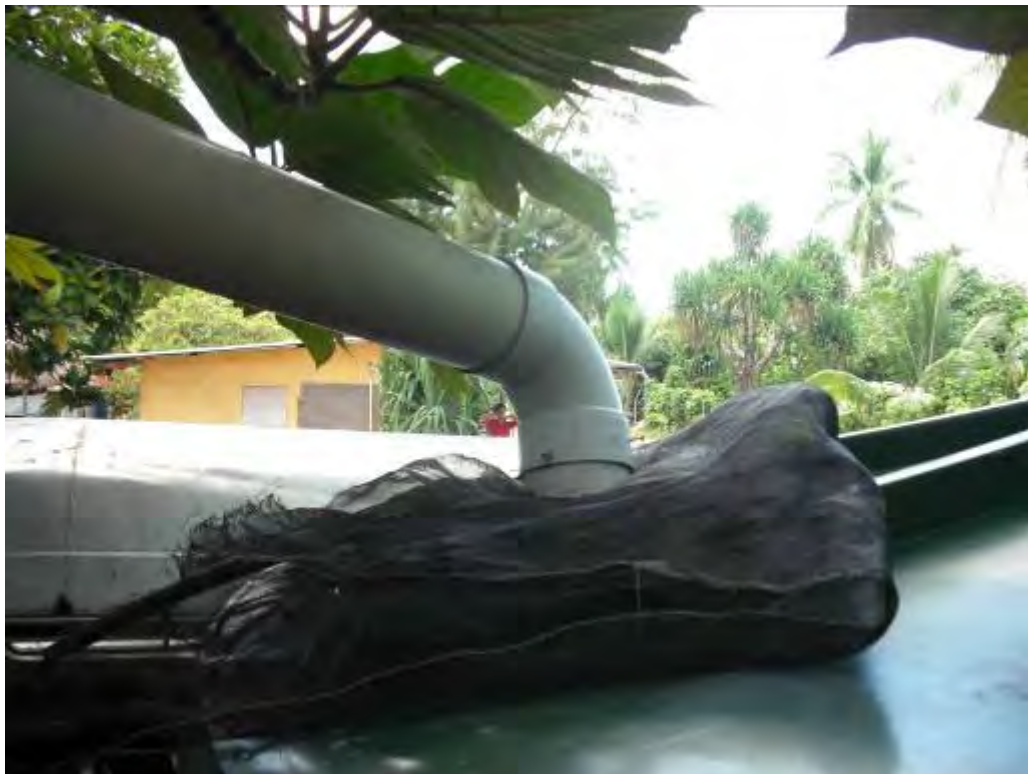
A1.2.3 Makeshift screen using mosquito mesh on tank entry.
