APPENDIX 1

Rainwater Harvesting Practises, Photograph Inventory

APPENDIX 1. RAINWATER HARVESTING PRACTISES, PHOTOGRAPH INVENTORY

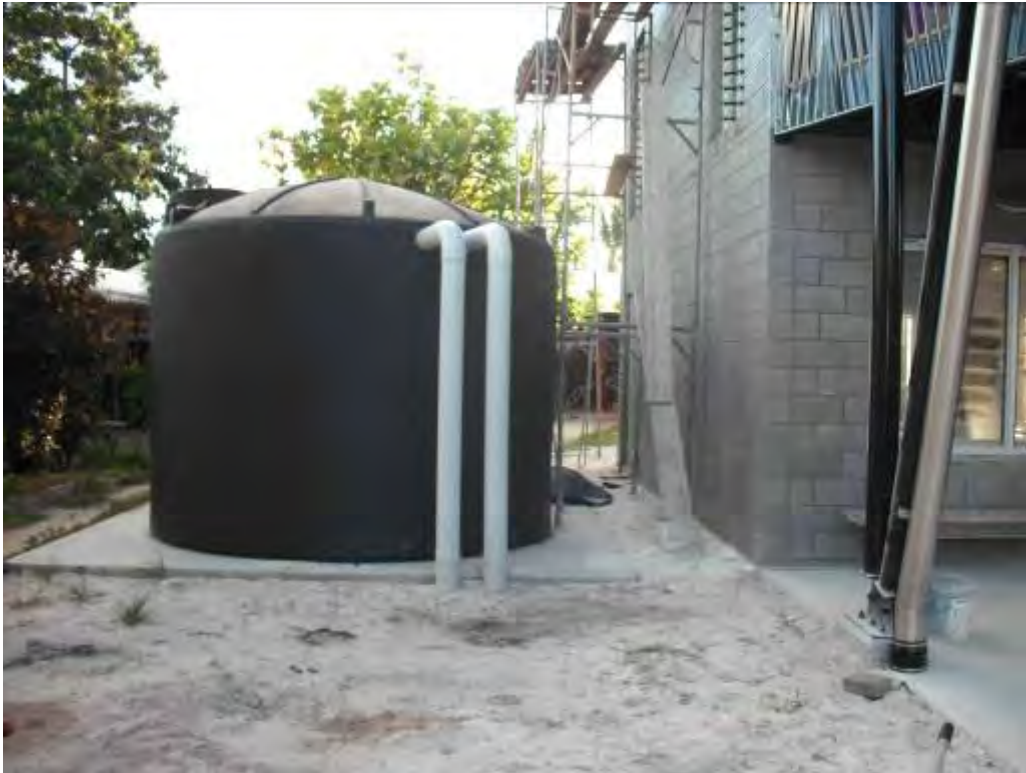
A1.3.1 Large imported 25KL polytank on flat reinforced concrete slab

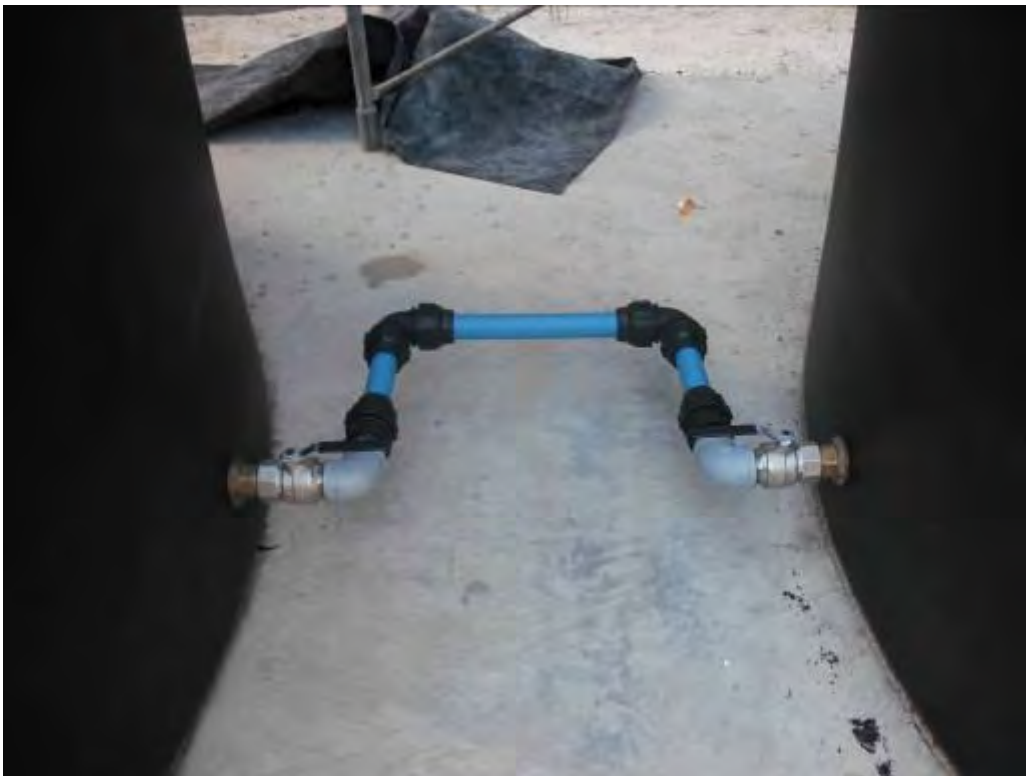
A1.3.2 Good tank connection, 50mm pipe with ball valves to isolate tanks

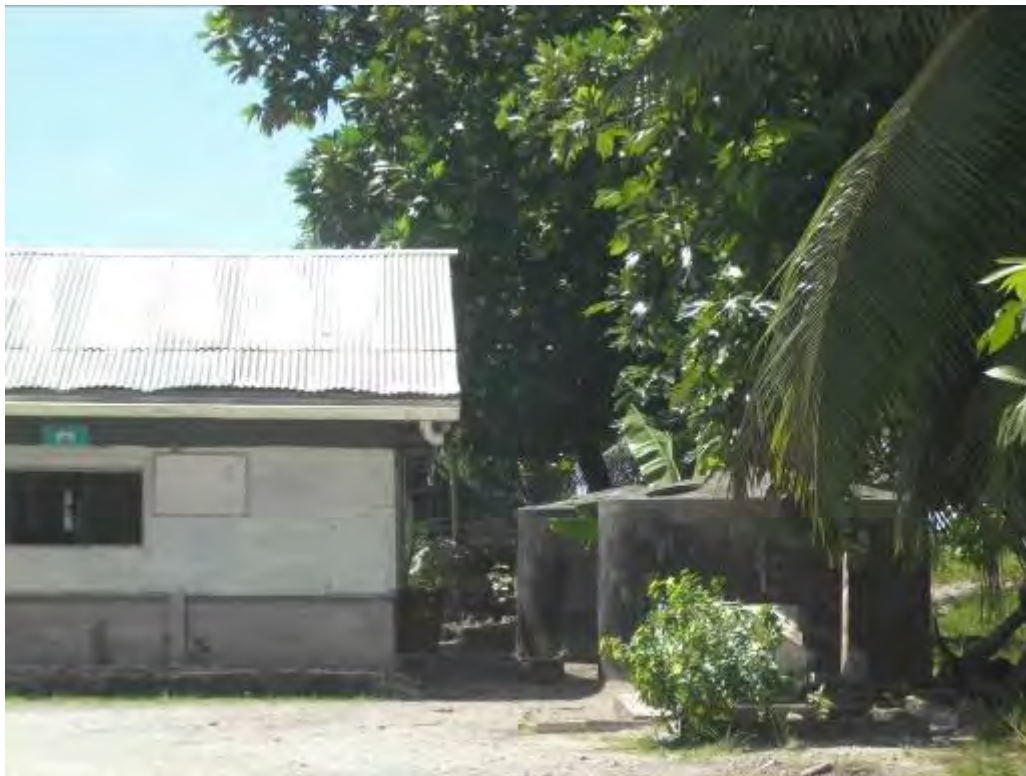
A1.3.3 Unconnected old ferro-cement tanks

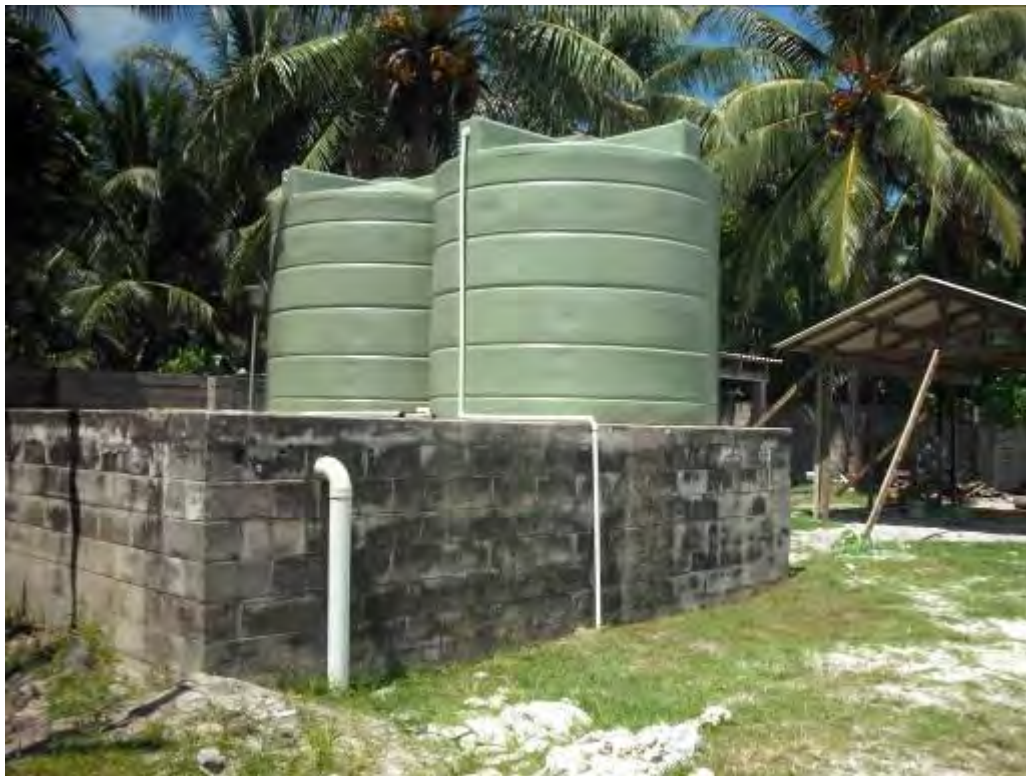
A1.3.4 Large semi-submerged block work cistern, with pumped elevated storage in 2 No. 10KL Poly tanks.

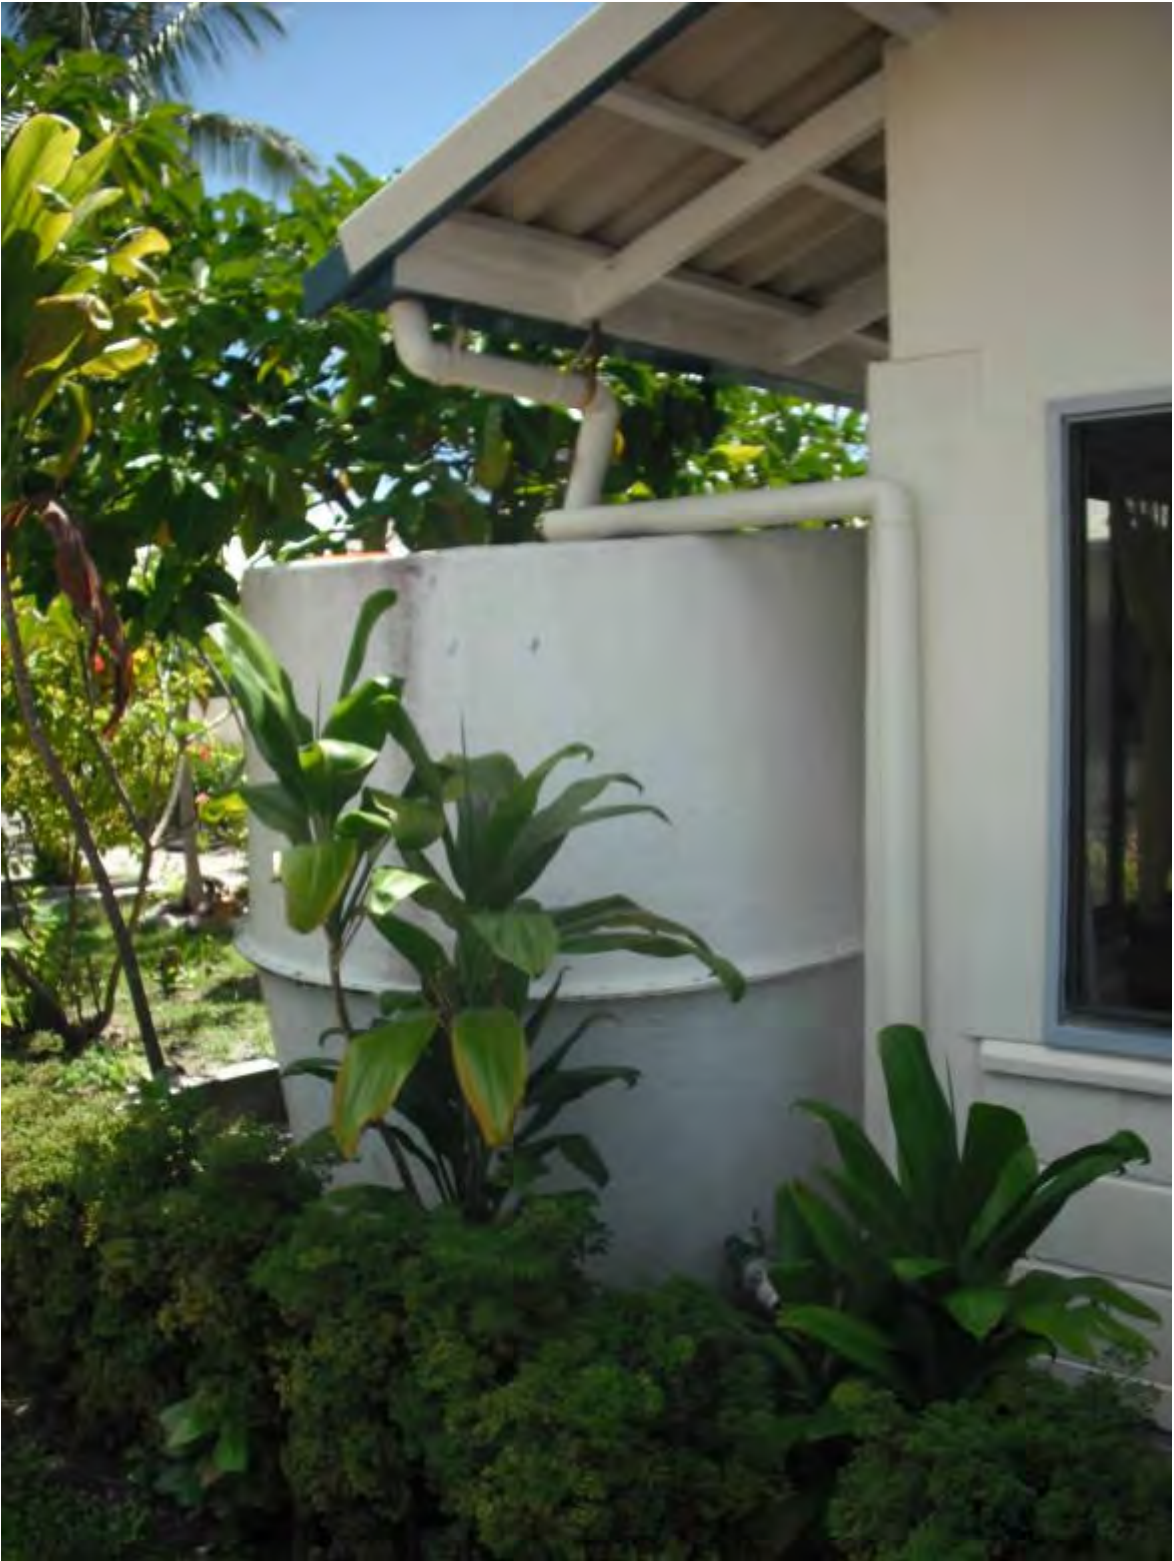
A1.3.5 Two piece fibreglass tank.

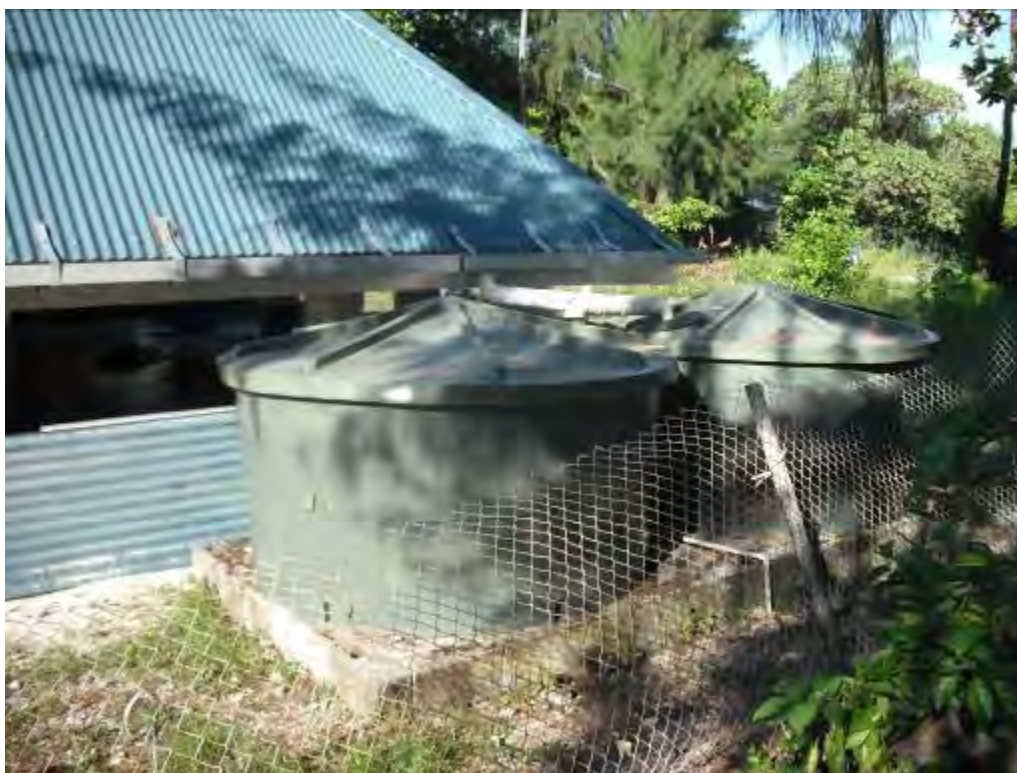
A1.3.6 Squat polytanks utilised where maneaba roof eaves are low.

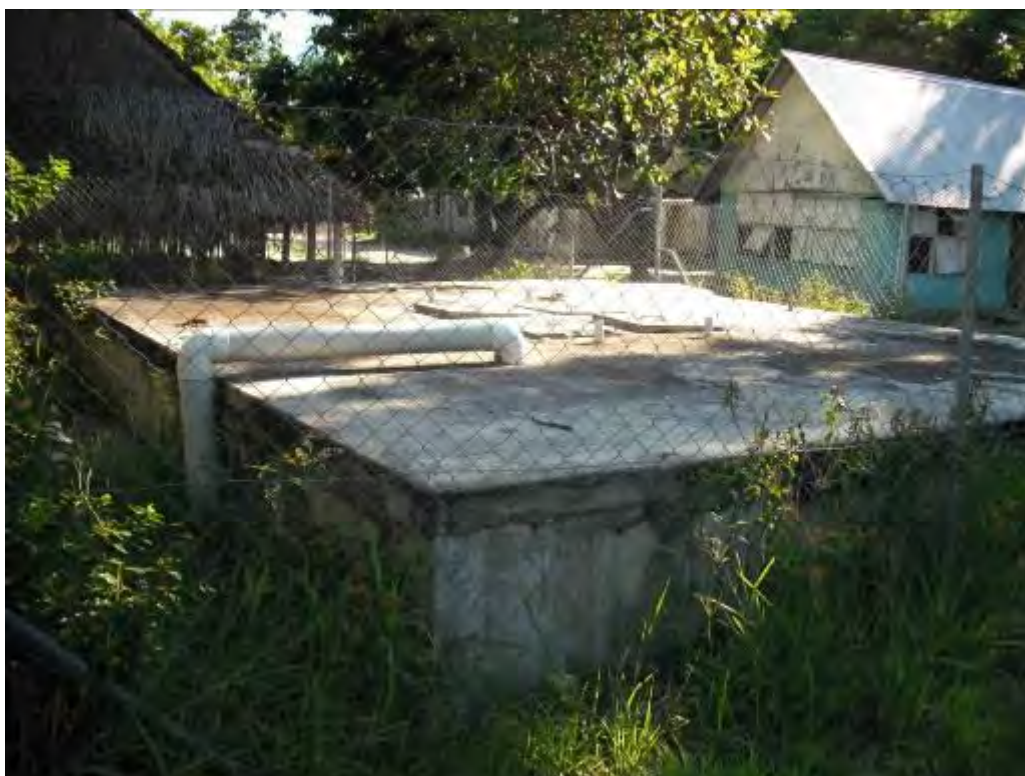
A1.3.7 Large semi-submerged reinforced concrete cistern.

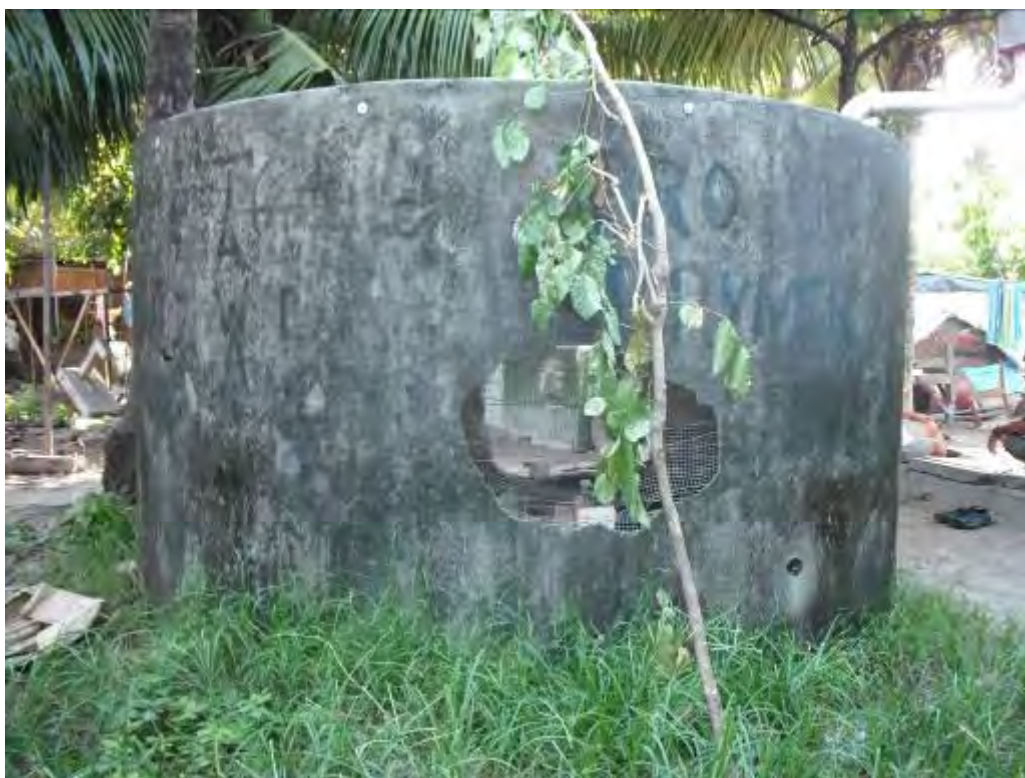
A1.3.7 Neglected 10KL ferro-cement tank

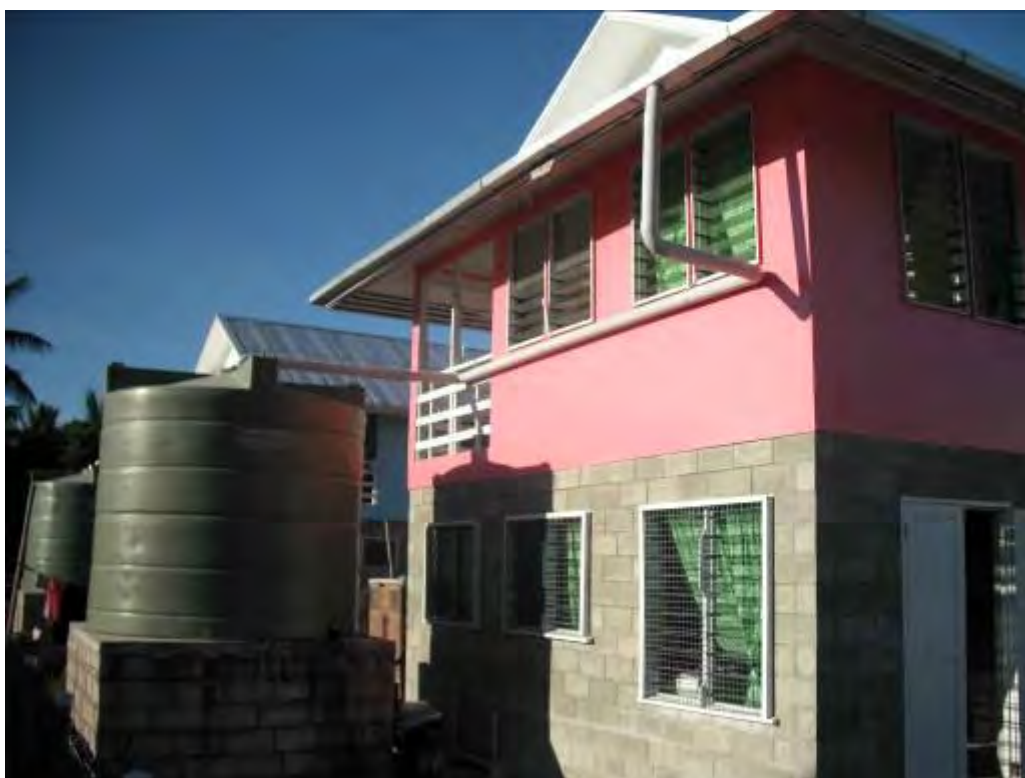
A1.3.8 Elevated 10KL polytank to utilise potential energy provided by high roof eaves.

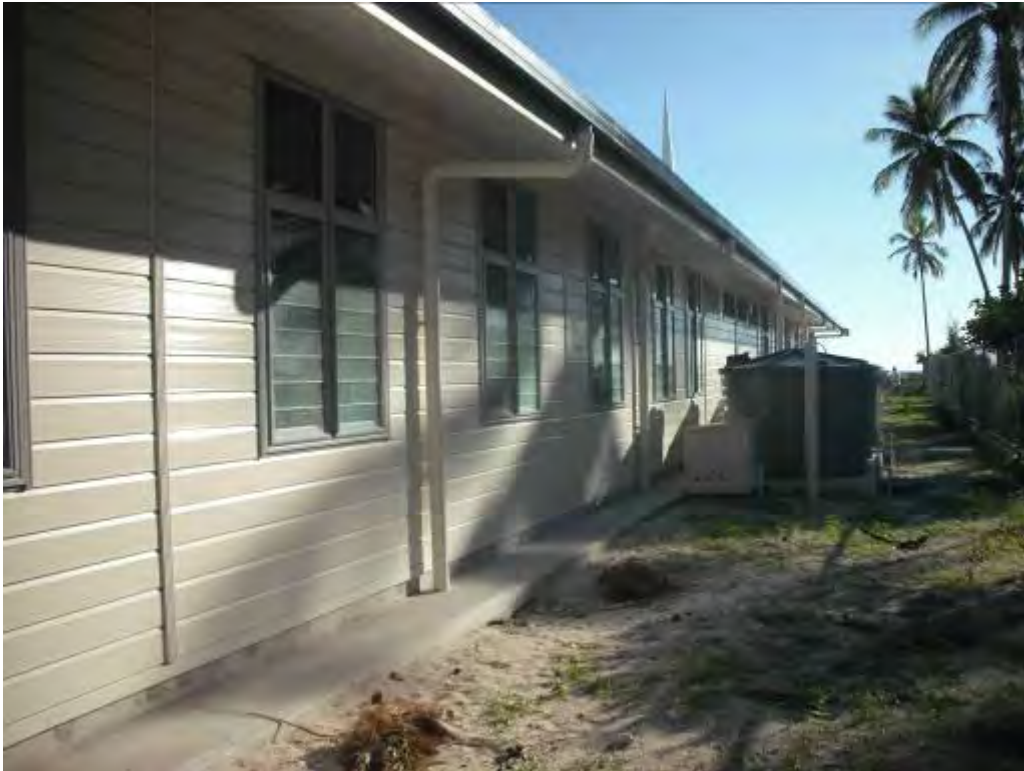
A1.4.1 Well constructed guttering system with adequate downpipes, underground transmission and significant storage in connected polytanks.

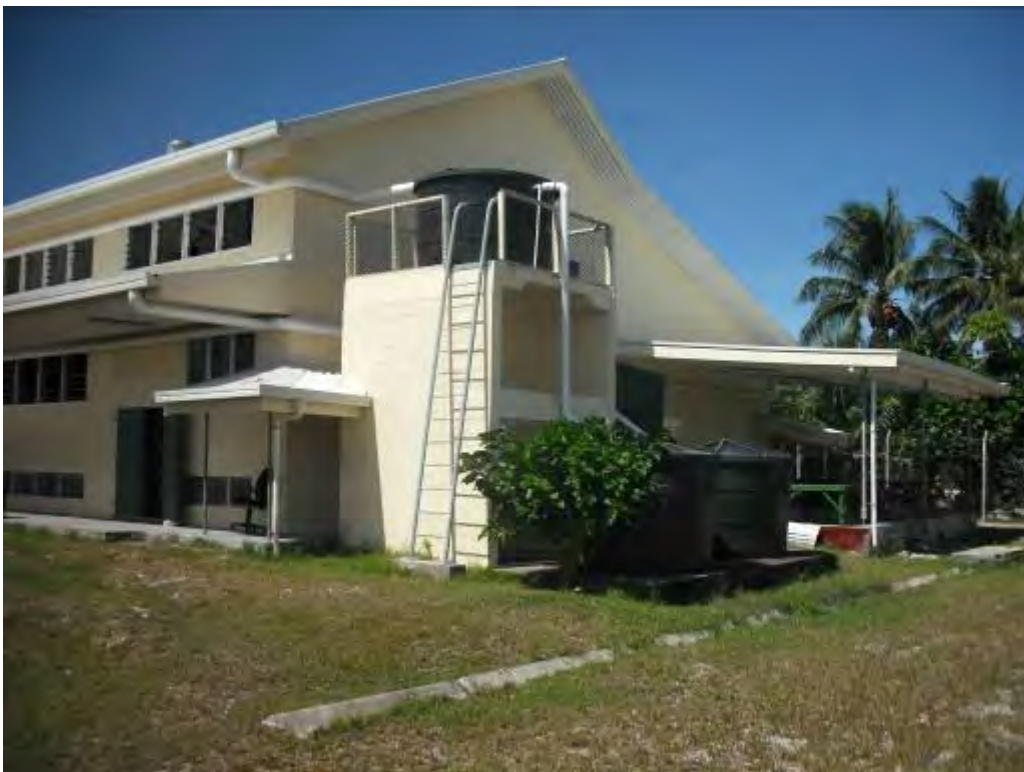
A1.4.2 Well designed and constructed collection, transmission and storage system. Overflows routed to a soakaway. Unfortunately, collected water is not fully utilised. There is no ownership of the water at Government buildings.

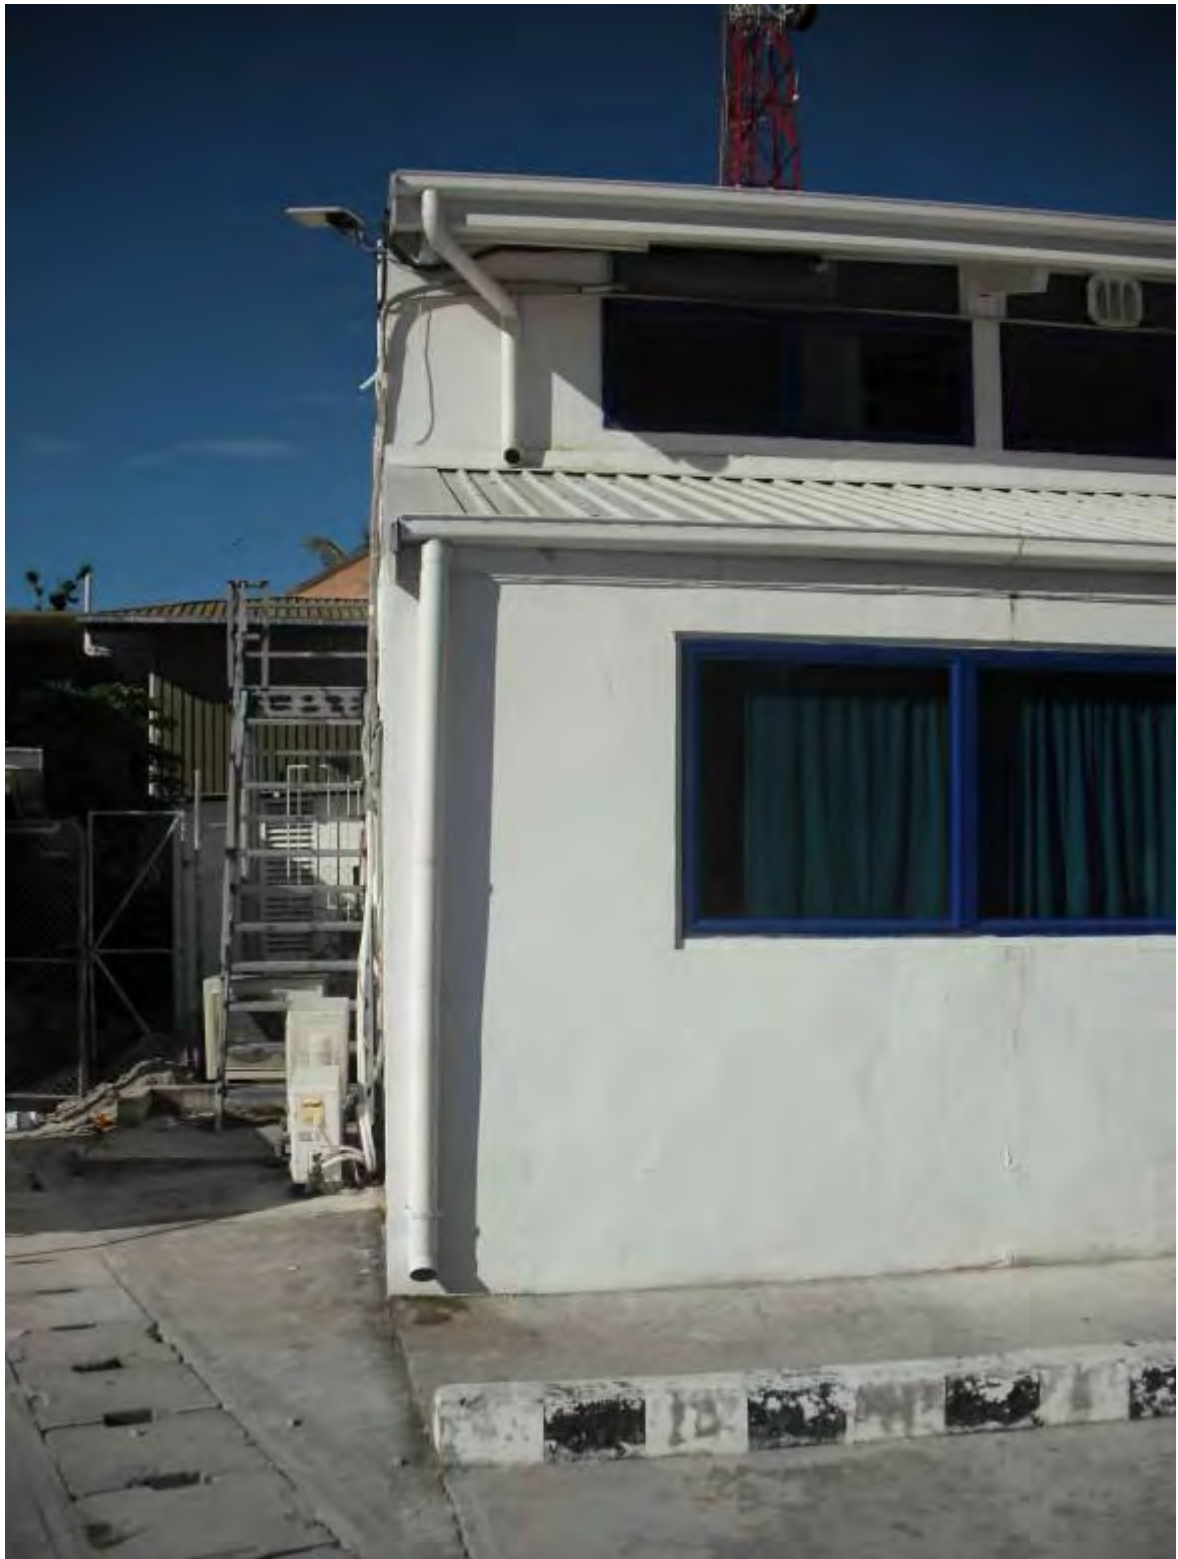
A1.4.3 well designed collection system with no storage.
