APPENDIX 2

Rainwater Harvesting Records

Appendix 2.1 Abaiang Maneaba

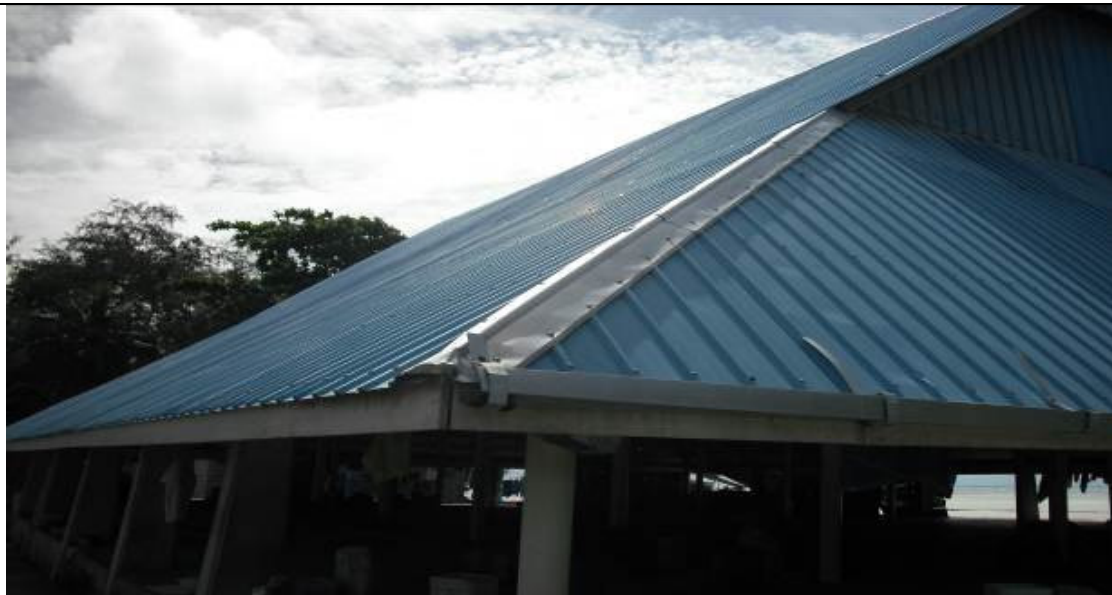
Concrete base of maneaba extends 1m from roof edge. Needs consideration in downpipe design. Although poorly managed the RWH system seems ok and is currently full. Makeshift repairs are made when required.

Galvanised steel guttering, steel strap supports, only 50% of the potential catchment guttered. Fall on the gutter can be observed.

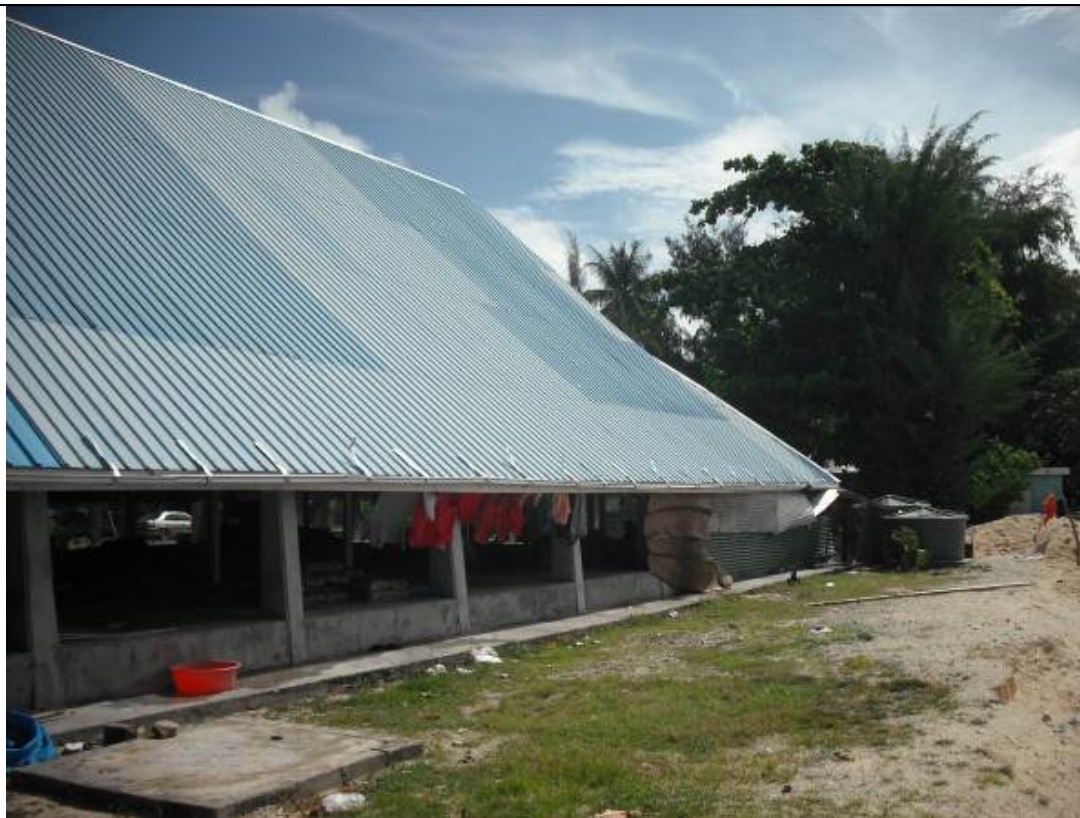
Hanging downpipe at risk of failure. Good fall on gutter. Gutter capacity insufficient considering single downpipe

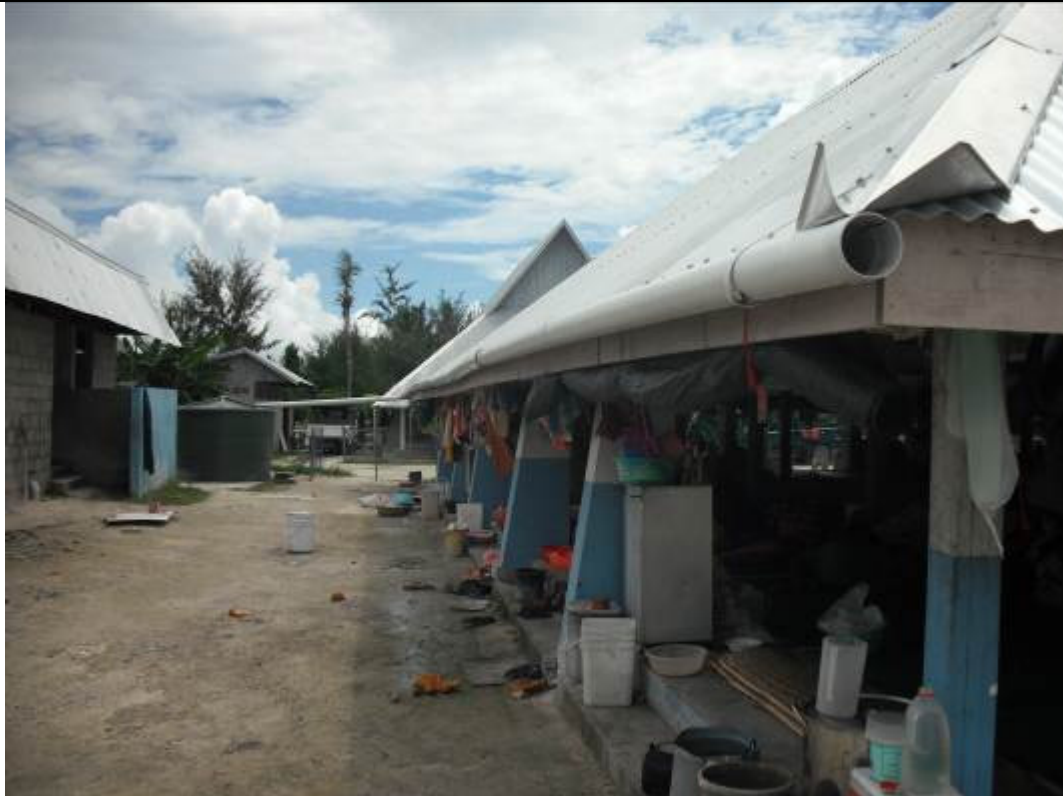
Split PVC piping used as guttering

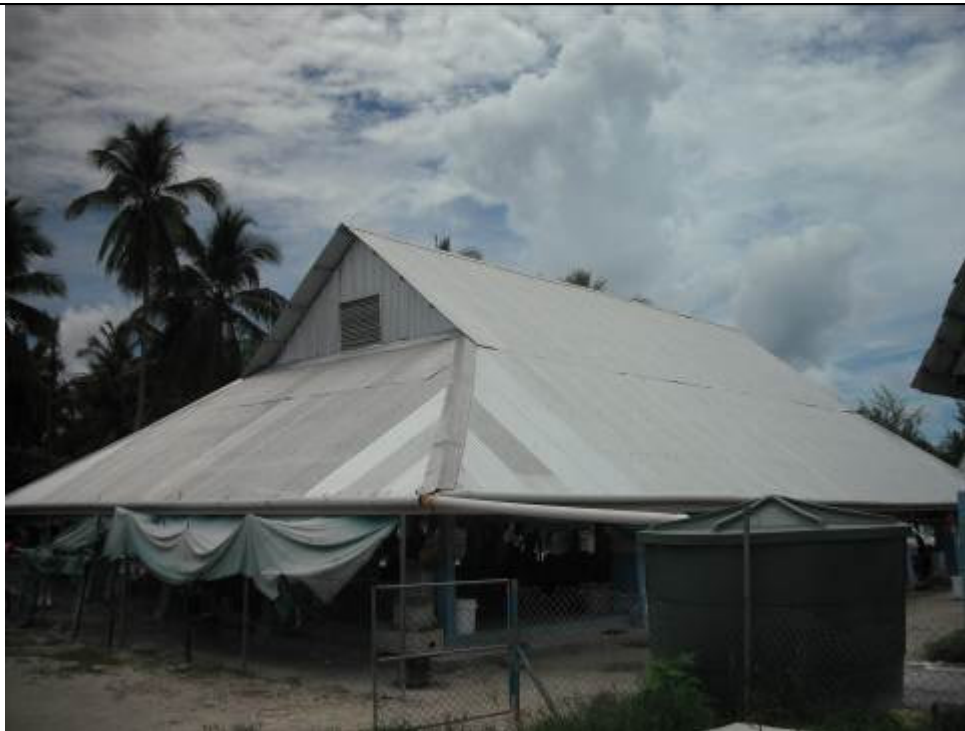
Guttering along both side of property leading to PVC down pipe into water tank. Roof in good condition, no leaves/debris – no need for first flush (?)

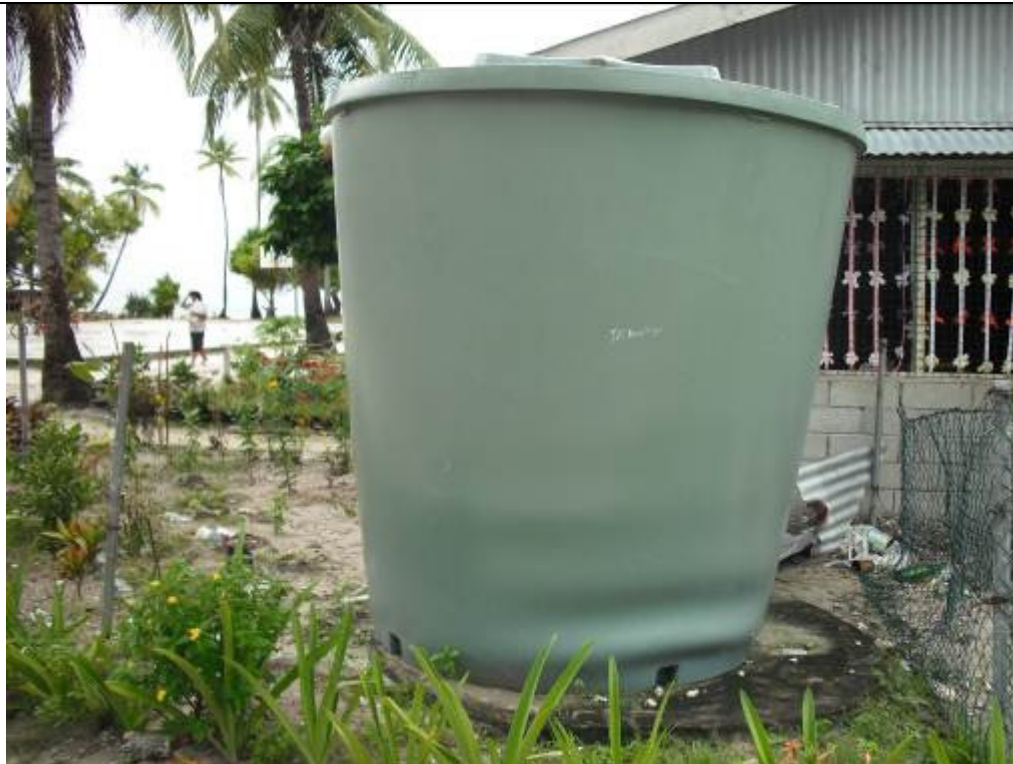
Deformity of water tank

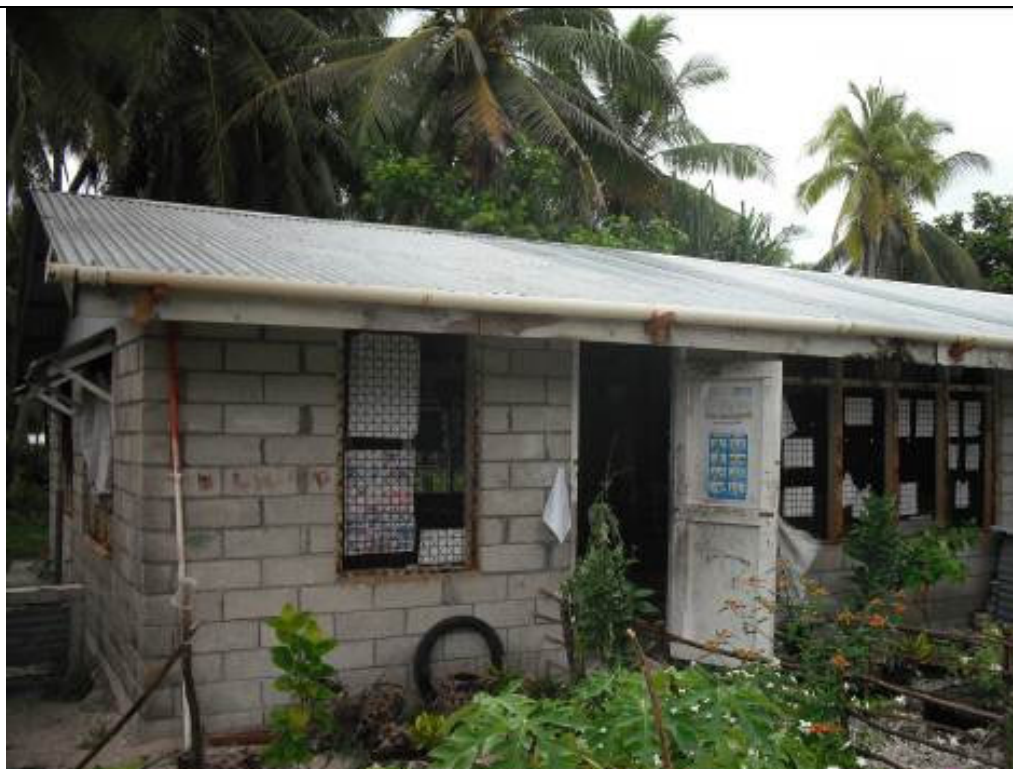
Good roofing and guttering along entire side of houses

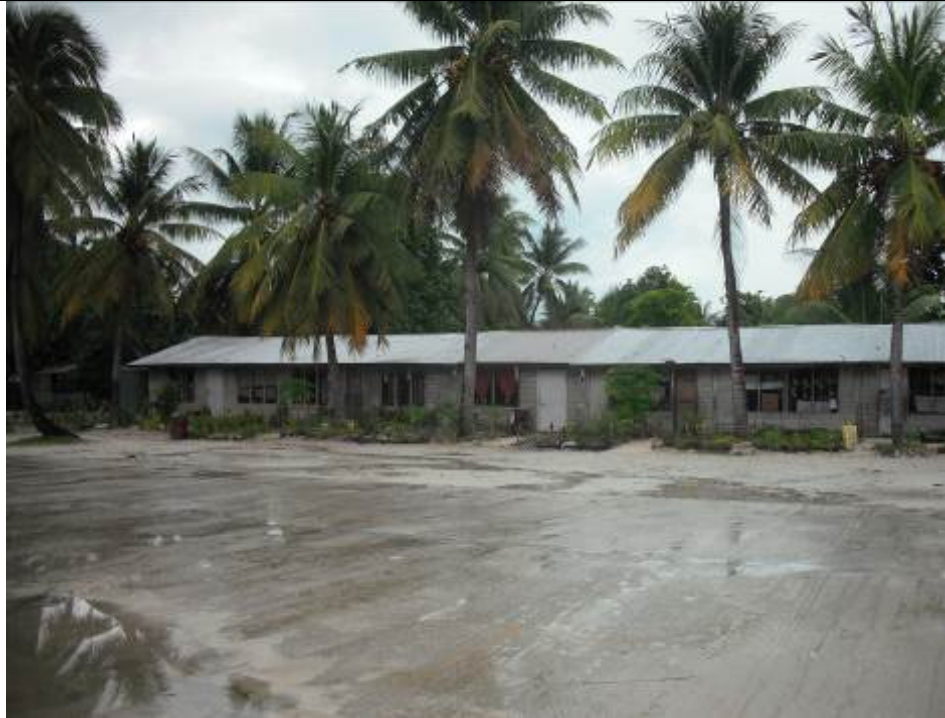
clear, undamaged roof across building 4

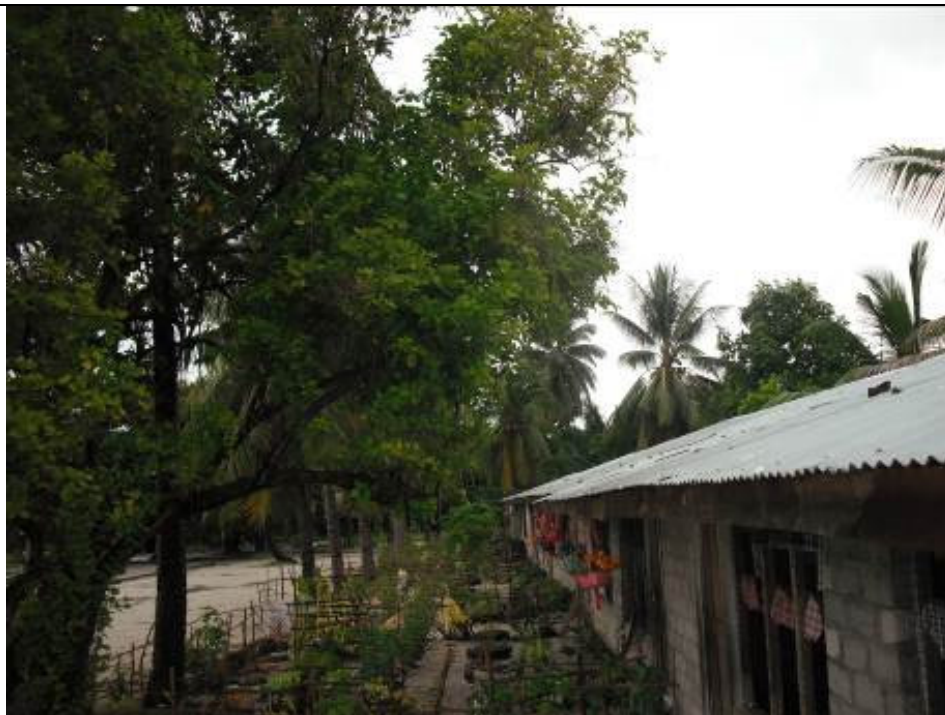
Fascia is rotten in some places as it protrudes from under roof and water drips onto it. The roof beams are various lengths, so fitting good new fascia would be a task and gutters would have to be fitted at different lengths along the fascia. A continuous gutter could not be fitted to either side.

Building 4 – potential for rainwater harvesting

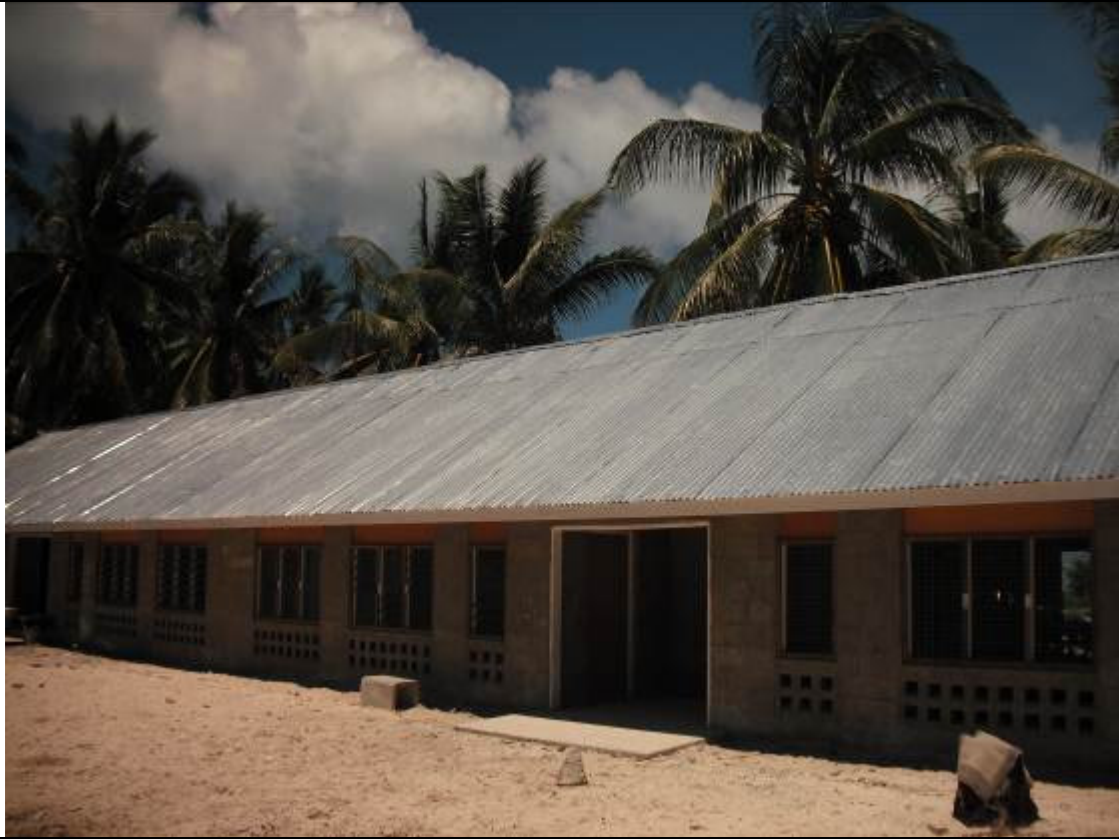
Excellent quality roof but no guttering

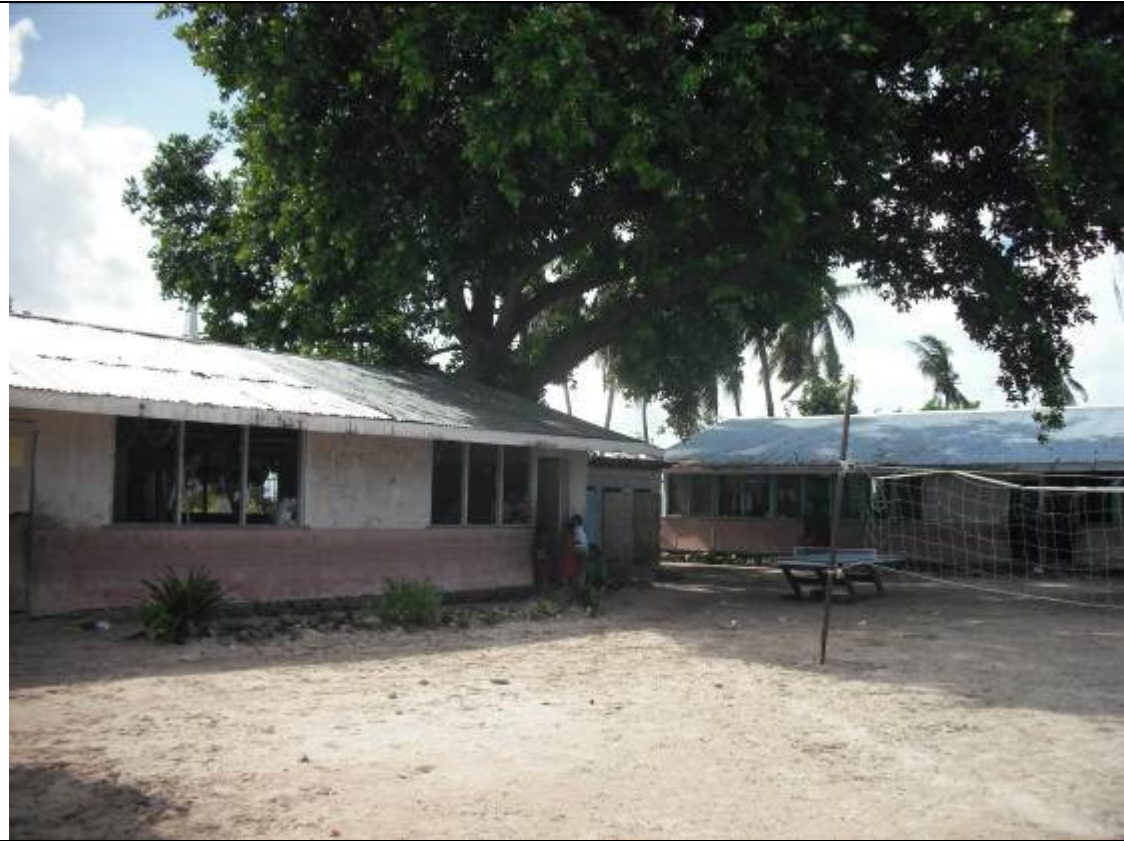
No guttering along roofs on either property

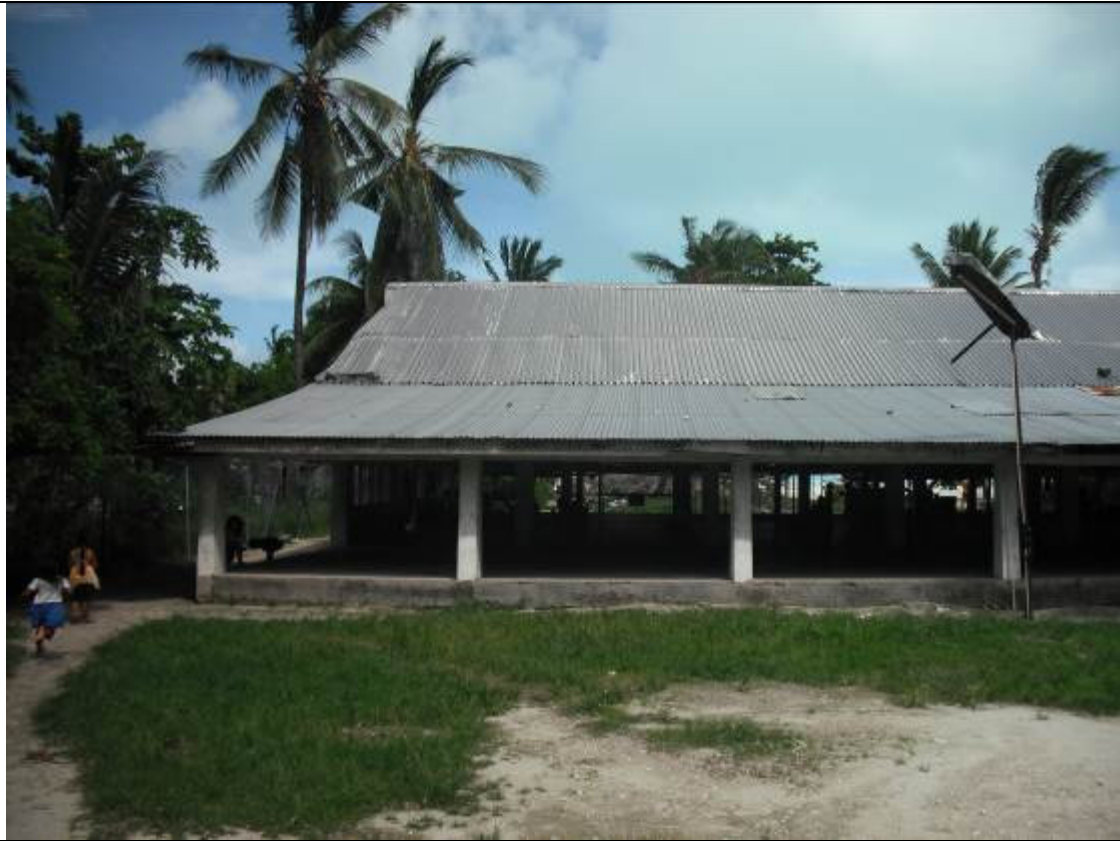
Good conditioned roofing, however no guttering along entire length of property

Front half suitable. At the back there are lots of temporary extensions to the maneaba, which are required and would interfere with gutter system. They are required so it is likely that they would be reinstated after any work. Suggest front is only suitable. So catchment 326 and gutter required 24.75.

Run overflows to the reserve tanks as they are already used as a reserve supply for the community in drought which is excellent. Distance to reserve tanks, *circa* 40m.

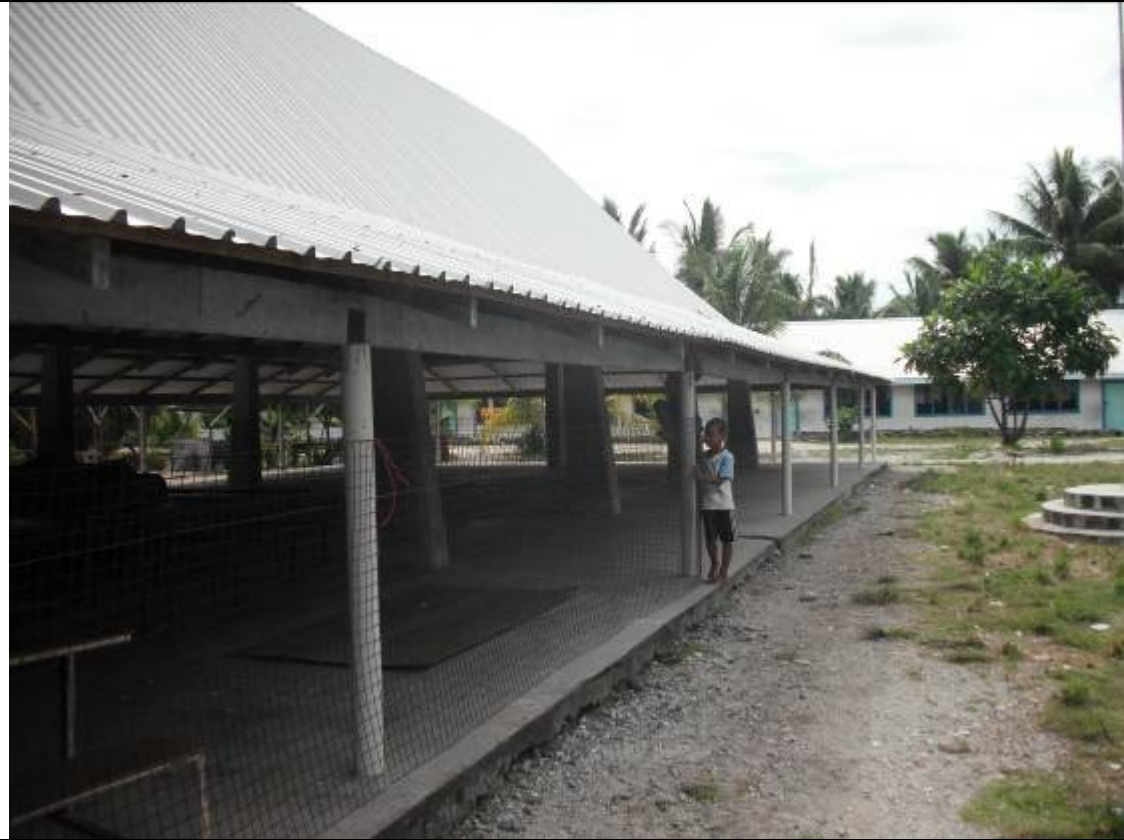
No guttering present around entire building

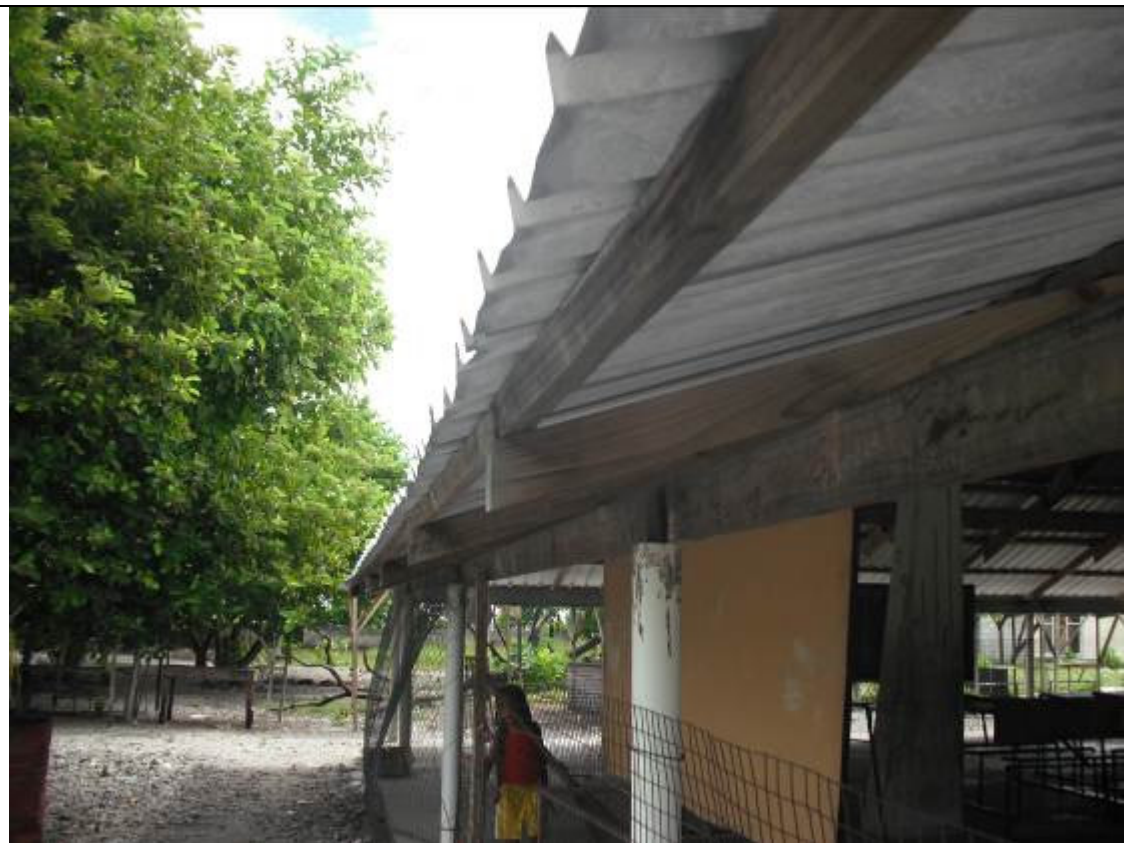
Again no guttering to catch rainwater

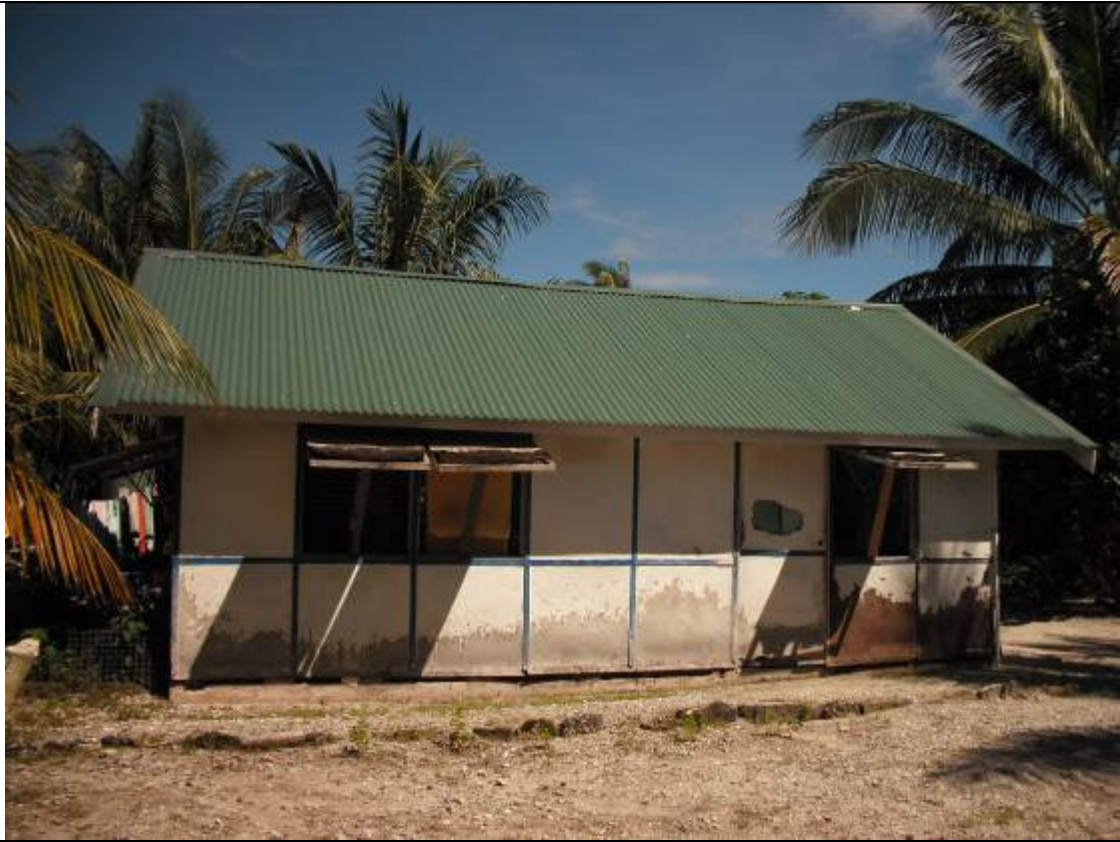
Good quality roofing but no guttering

2 houses the same in this location 10m apart. Route overflows to well in the centre 7m from proposed tank locations.

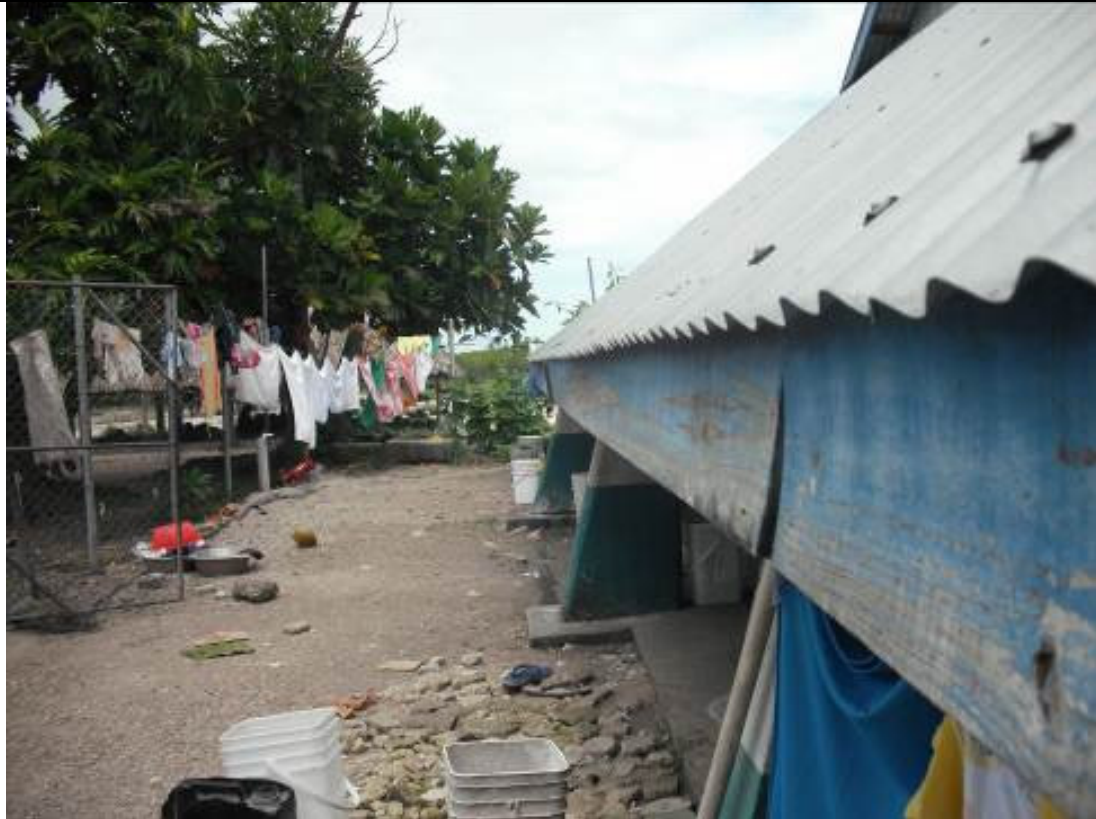
No guttering. Low roof. Fascia board in reasonable condition. Could use squat tanks?

Low roof (1.3m). Areas to the north (10m) with lower elevation, could locate the tanks here. Or use squat tanks. Also, a well for overflows to the north.

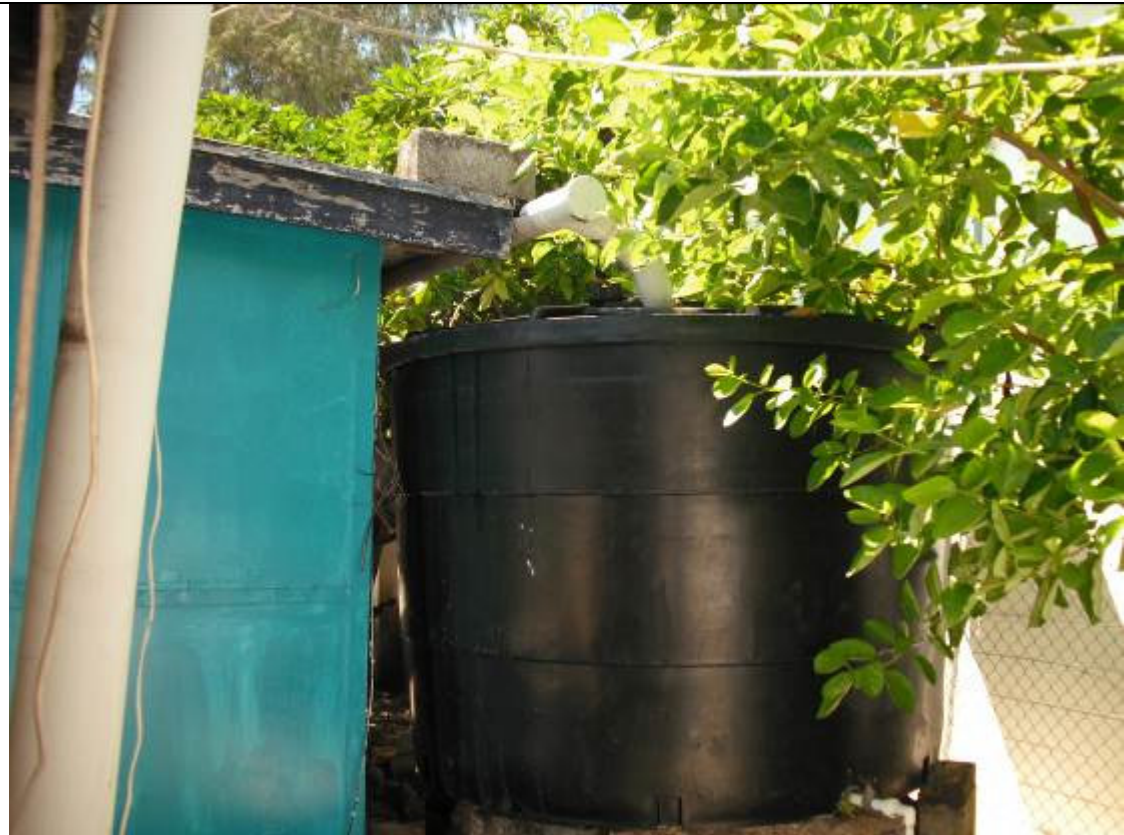
Elevated water tank and down pipe

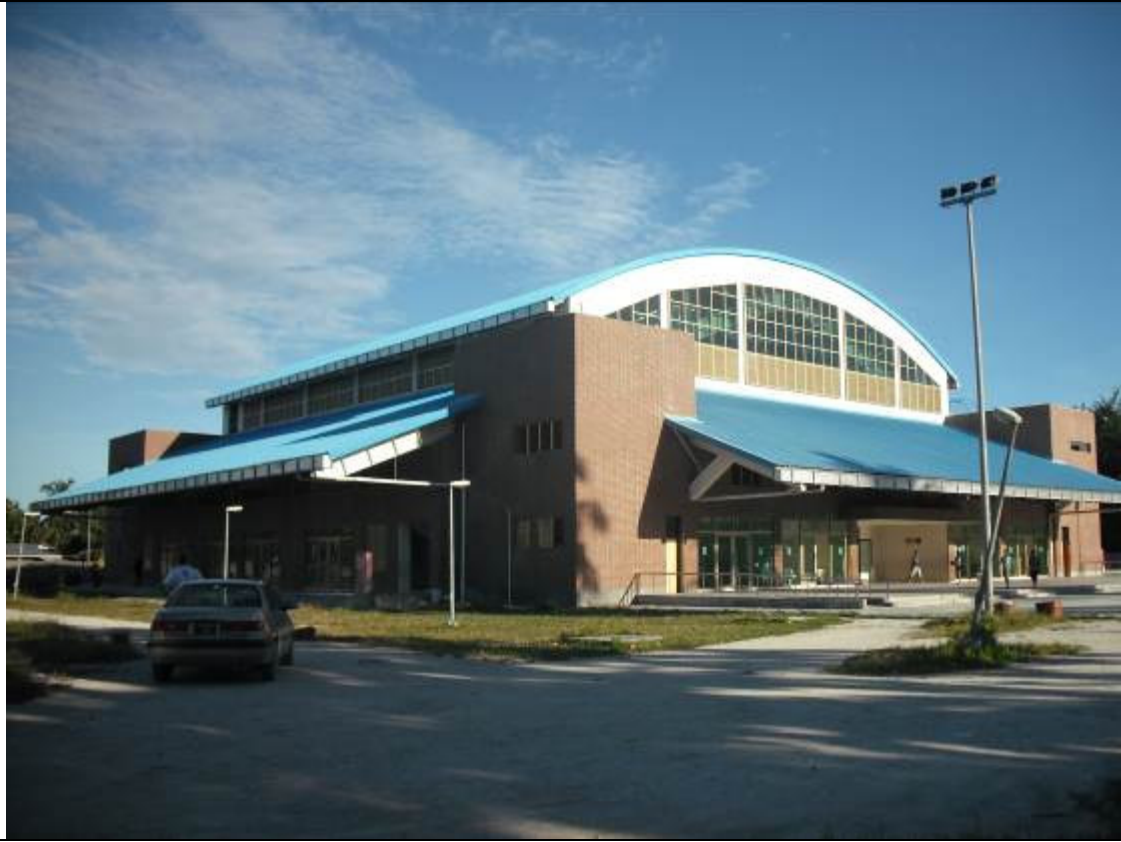
New building, good quality roof and guttering present. Routed to underground reinforced concrete water cistern
