**UNACCOUNTED FOR WATER
AND LEAKAGE ASSESSMENT**

**PREPARED FOR KAP II PROJECT
TARAWA, REPUBLIC OF KIRIBATI**

AUGUST 2010

**Pipeline Network Analysis
PO Box 1345
Southport, 4215
Queensland Australia**

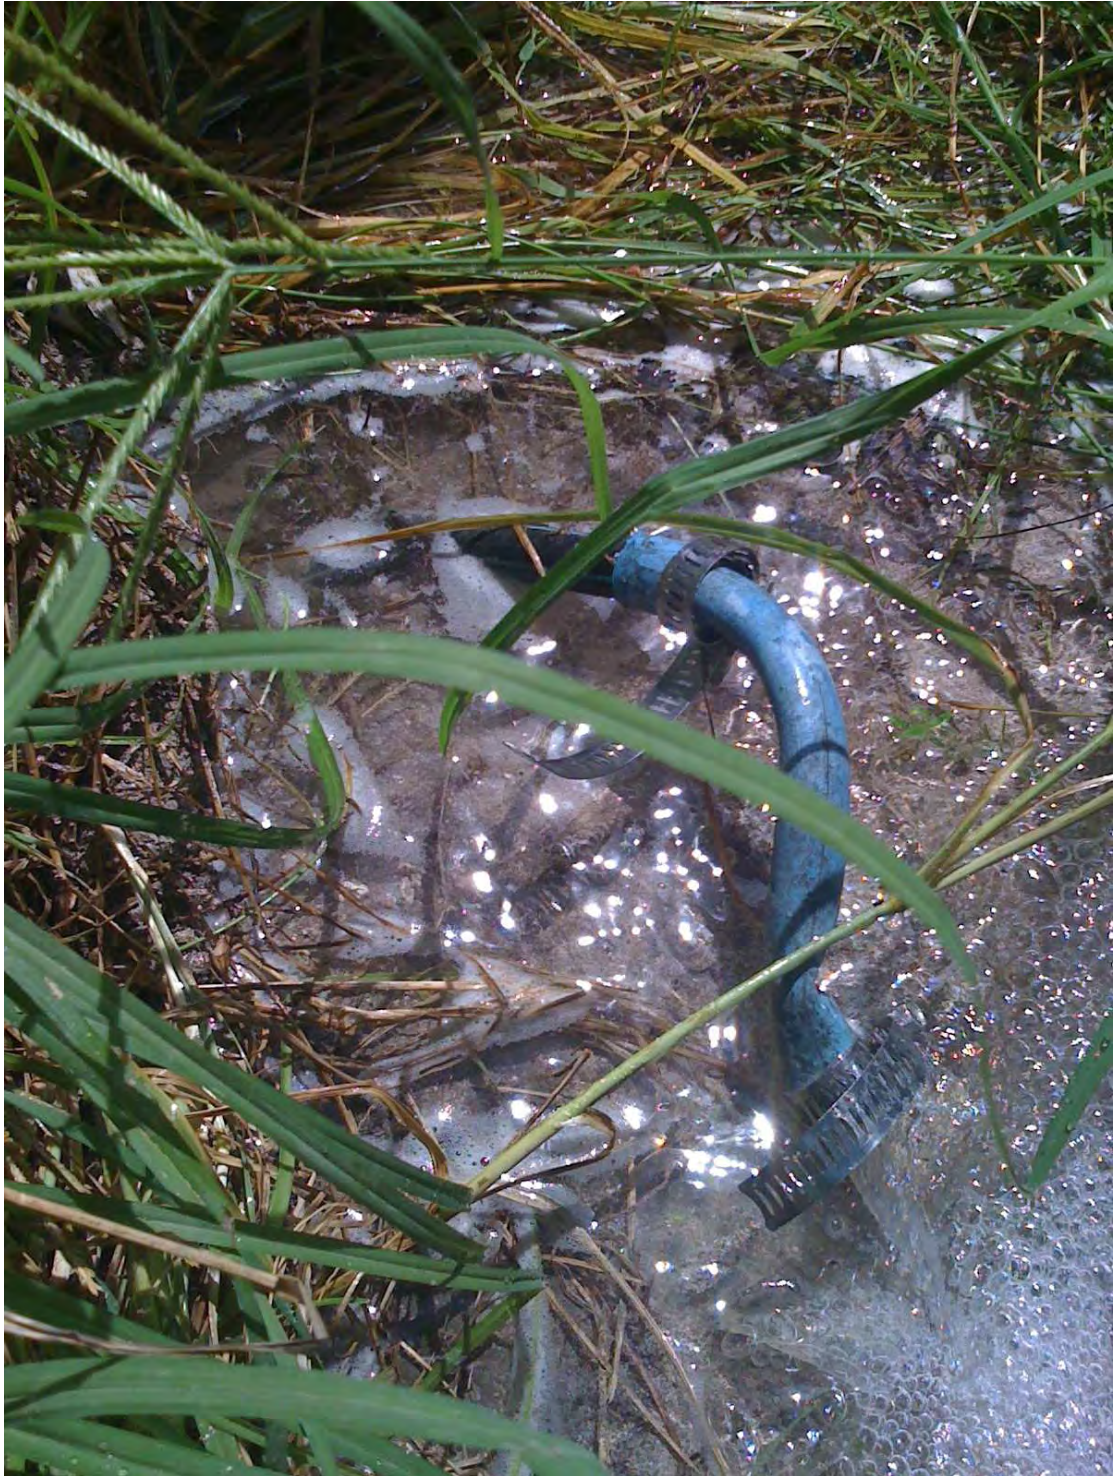
Typical illegal connection. Note hose clamp to fasten on to PUB service main. When water in the zone is switched on, the hose is used to fill buckets, and water will continue to flow. This had been covered by a disused 55 gallon drum.

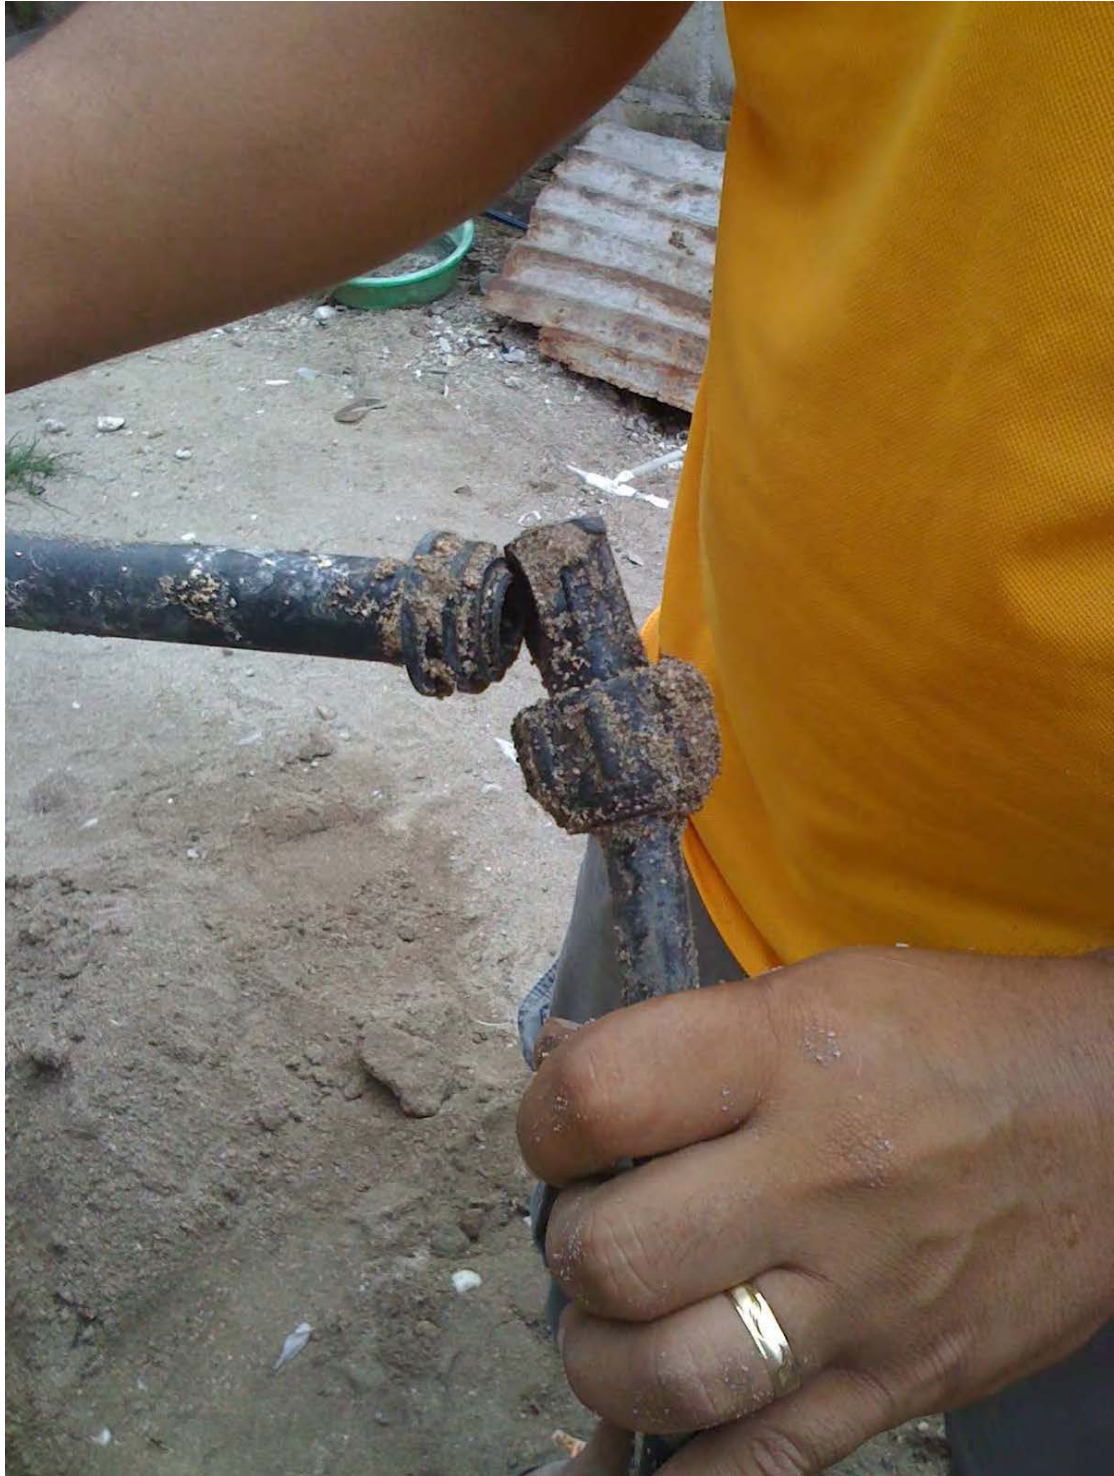
A severed 90 degree connection on disused but still connected line. Years of ground pressure forced the connection to snap at the elbow.

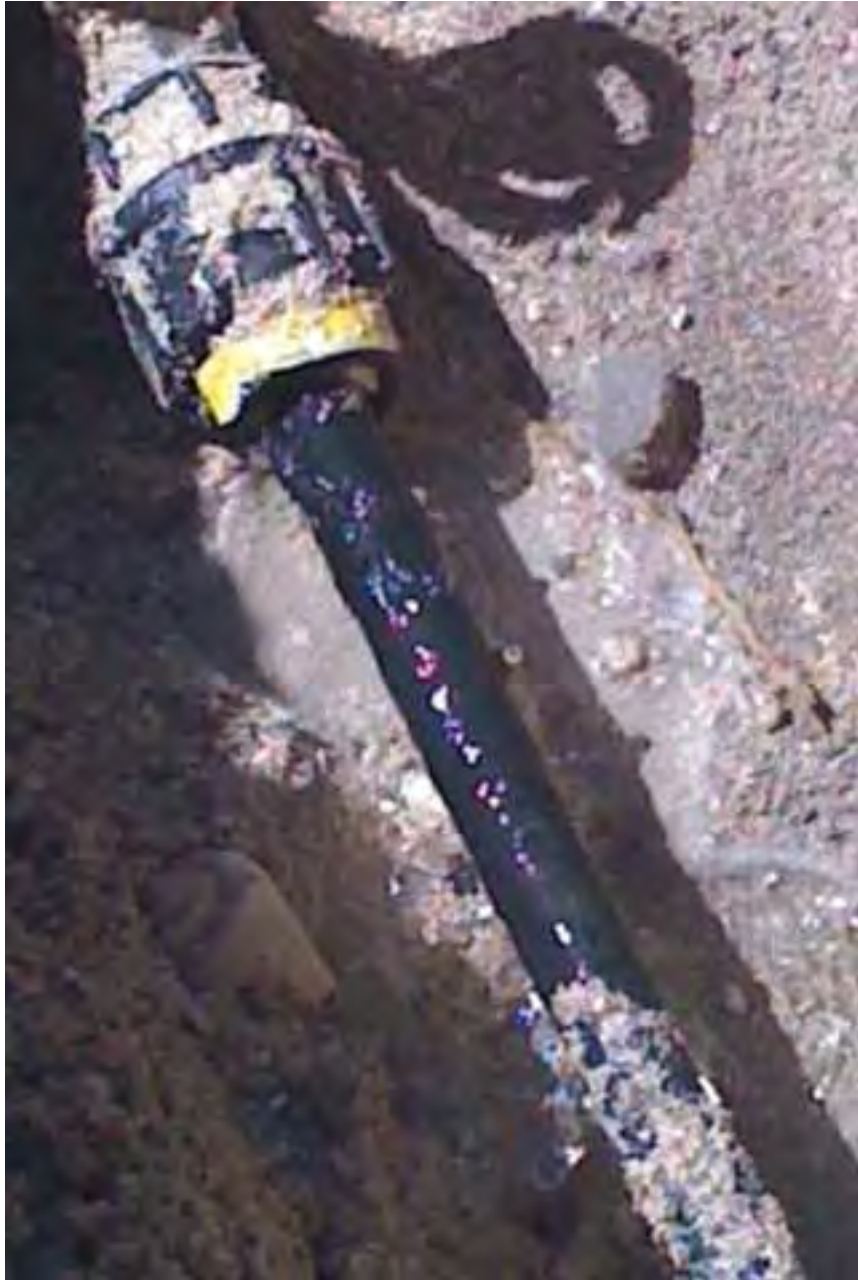
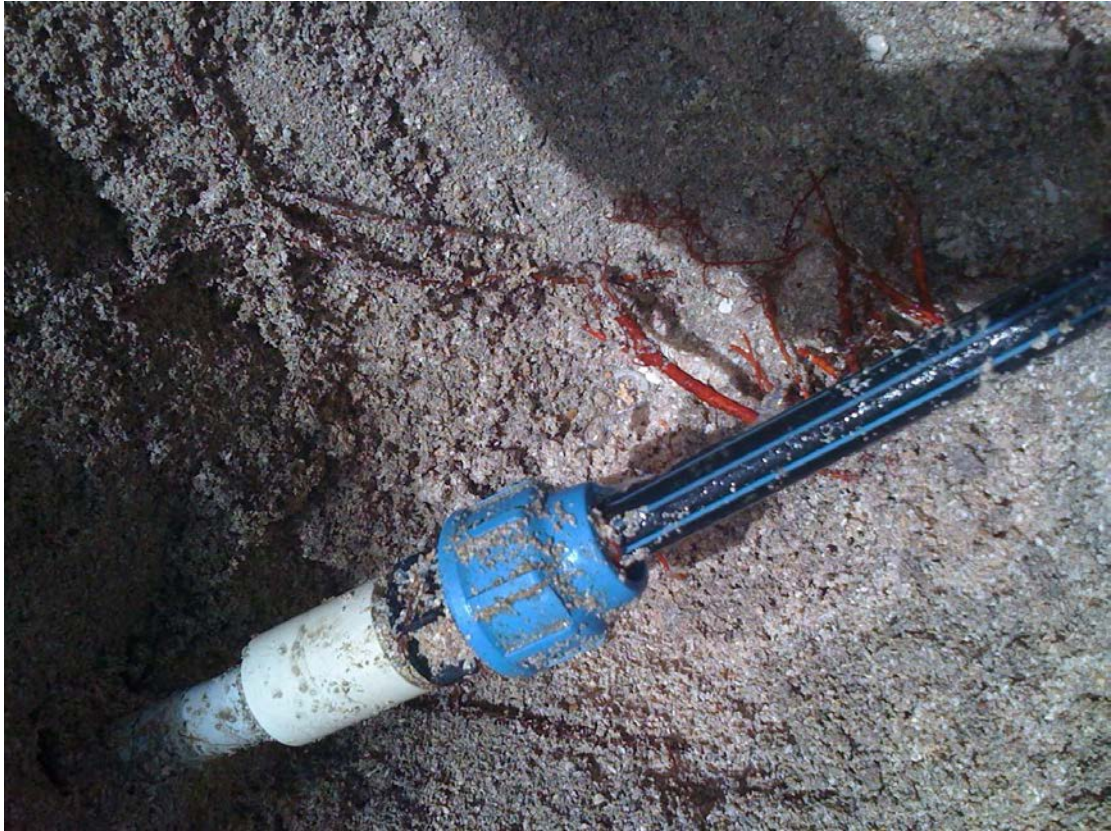
Most typical type of leak found, both above and below ground. A faulty connection or broken “O” ring in the fitting allows water to leak from the fitting. The following two photos are below ground.

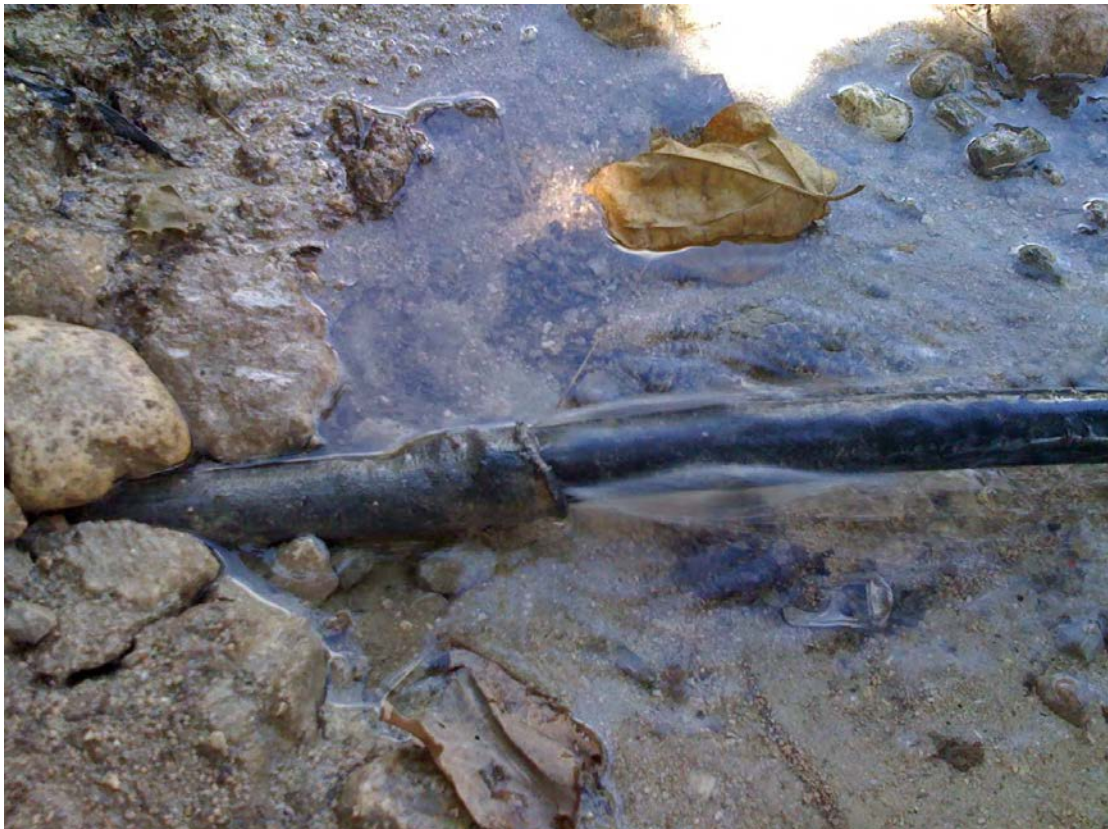
A “do it yourself” extension to get the water from the line closer to the house by forcing two pipe sections together. The only reason it didn’t blow apart was because of low system pressure. (See following photo)
