APPENDIX 2

Rainwater Harvesting Records

Appendix 2.1 Abaiang Maneaba

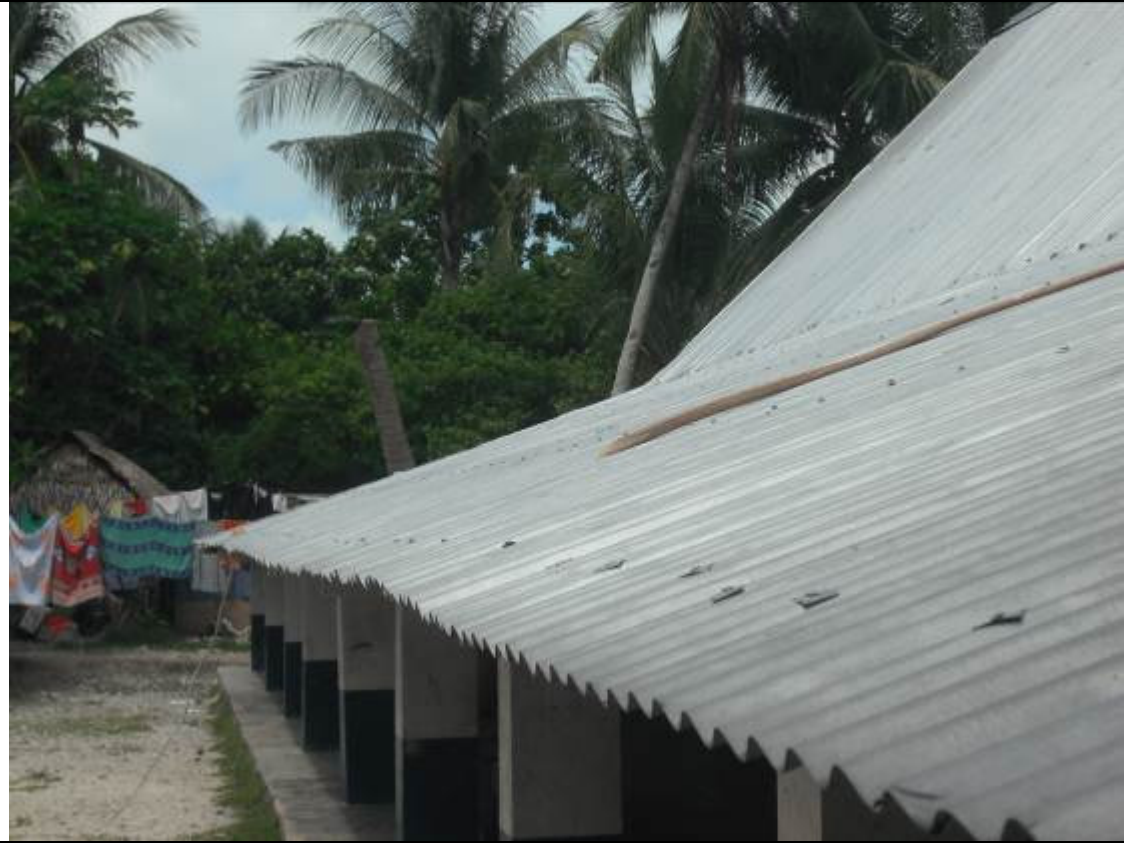
Might be hard to fit fascia. Roof beams only have 2 inch x 2 inch area for attaching.

Already have RWH on church but large village population use the water. Limited PUB supply in this area.

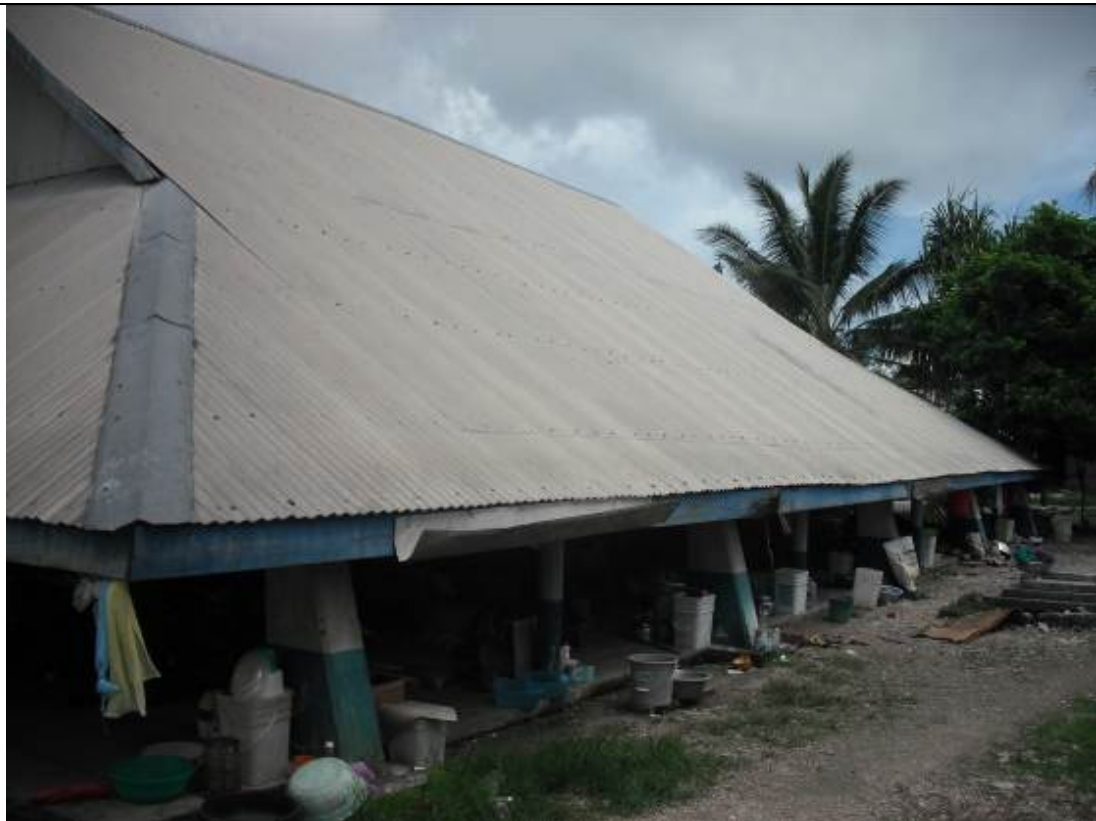
No guttering. Low roof. Fascia board in reasonable condition. Could use squat tanks?
